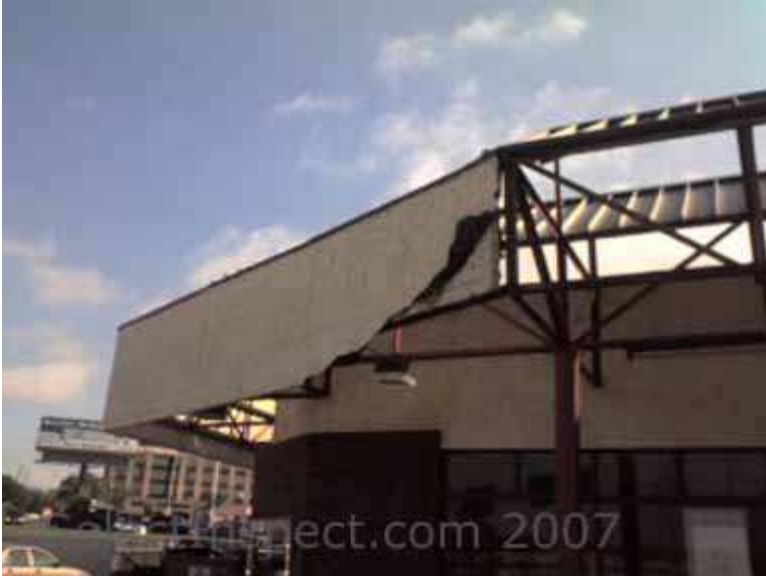
↑ deficient wood and stucco at sign structure- front view

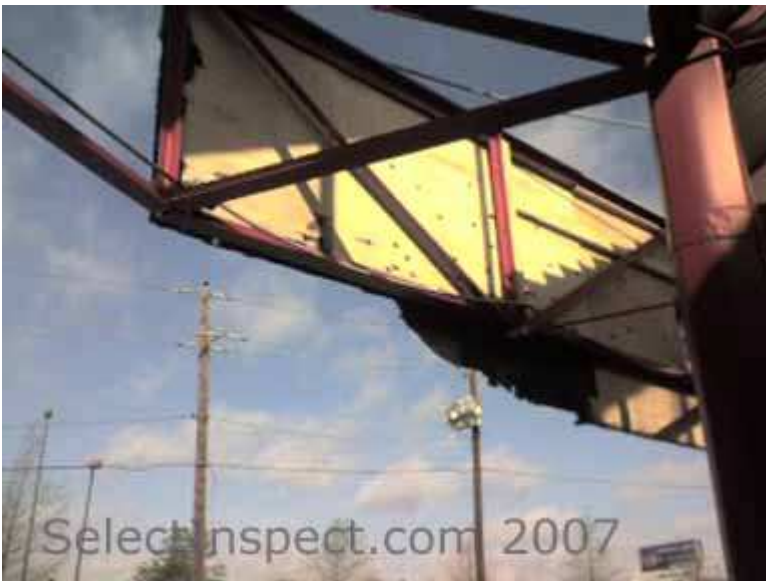
↑ deficient wood and stucco at sign structure- rear view

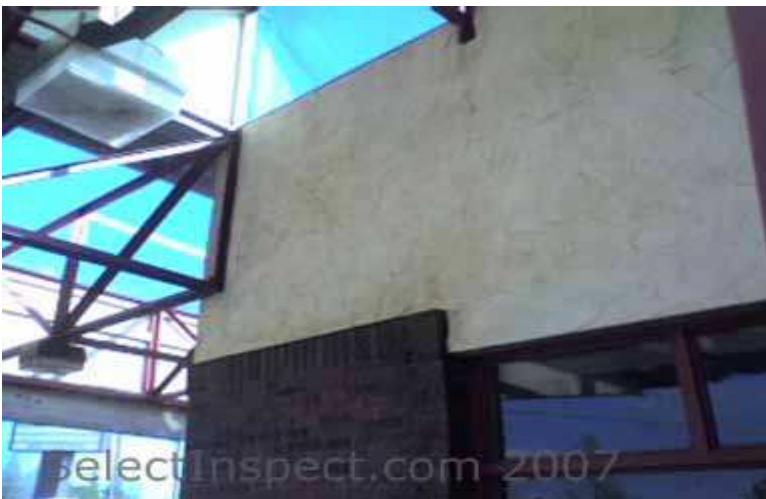
↑ moisture intrusion evidence behind stucco- example

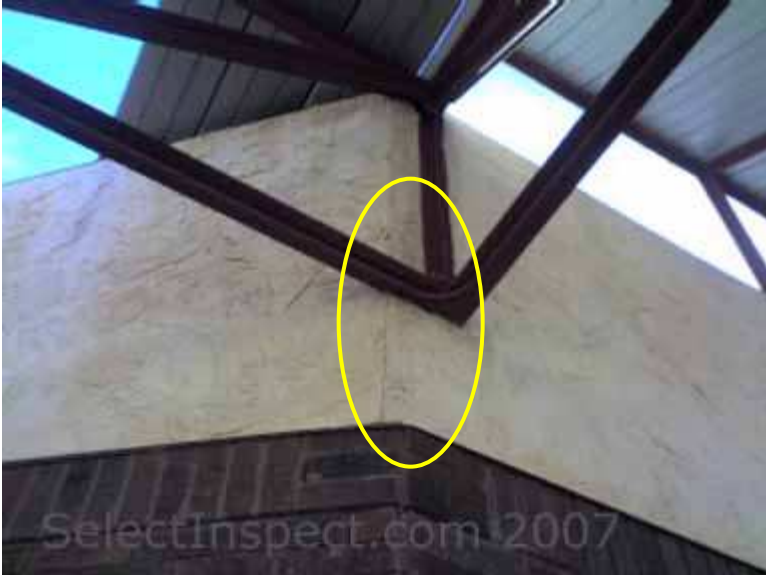
↑ moisture intrusion evidence and cracking at stucco- example

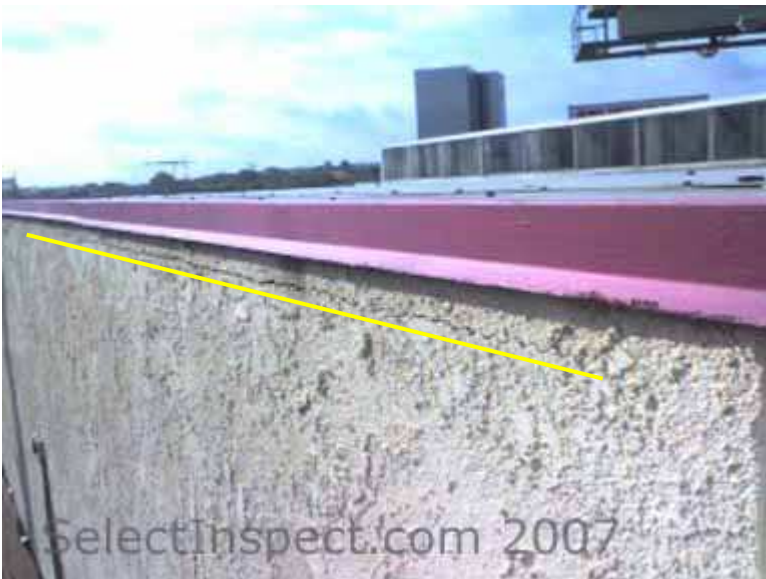
<b>DISCOVERIES</b>		
<b>Exterior Comments</b>	<b>Building or General Area discovered</b>	N/A
<b>Foundation</b>	Common stress indications including vertical stucco cracks at various perimeter locations and moderate horizontal crack at the east. Significant issues were not found or observed concerning this item at the time of inspection.	
<b>Structural</b>	Building structure and steel components appeared visibly stable. Condition of substrate behind stucco is questionable, as moisture intrusion evidence was noted at multiple exterior and interior locations. I suspect there is at least moderate framing decay and possible wood destroying insect evidence/activity in inaccessible wall voids. Such determination would require invasive measures, and such was not in the scope of this inspection. Wood and stucco sign components were in disrepair and full removal should be considered. These components were unstable, and potentially unsafe for tenants and patrons. One section was marginally supported by rope- integrity is very questionable, and failure is imminent, unless corrected.

↑ horizontal cracking at east / rear area of bldg below roof parapet

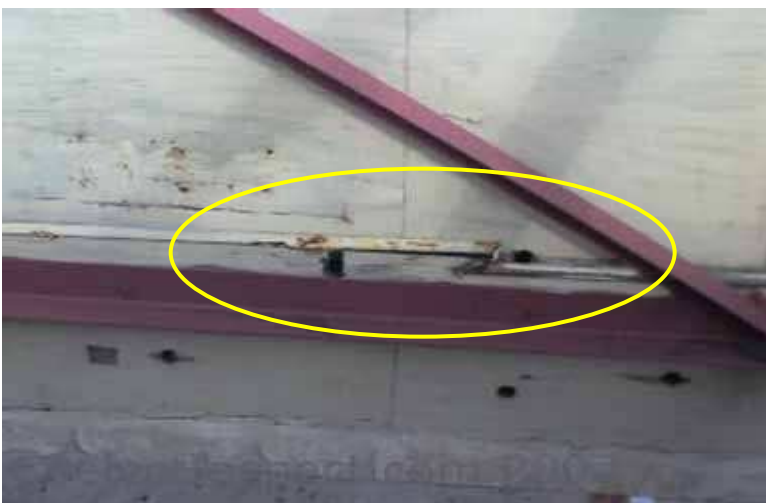
↑ amiss / deficient electrical at north behind sign structure

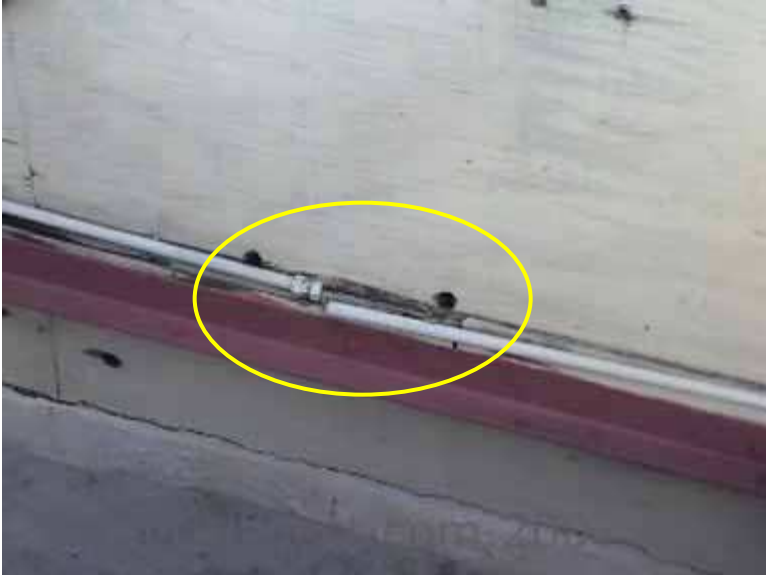
↑ amiss / deficient electrical at northwest behind sign structure

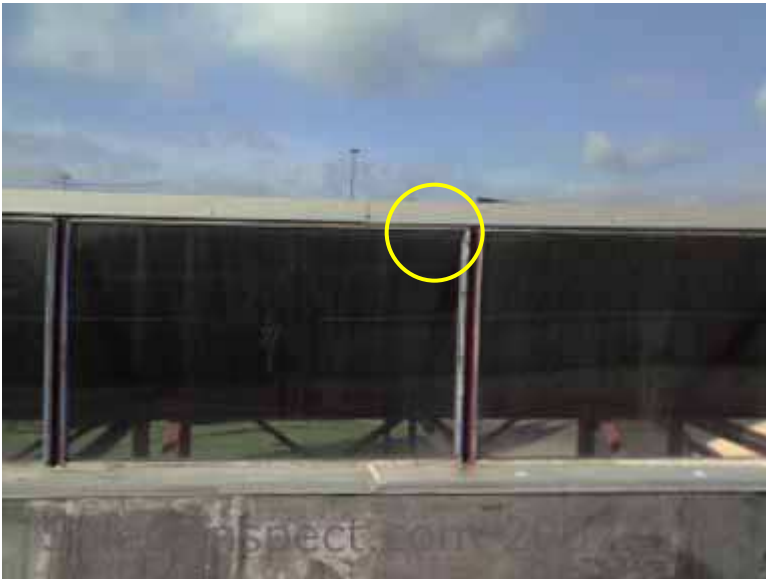
↑ cracked window location

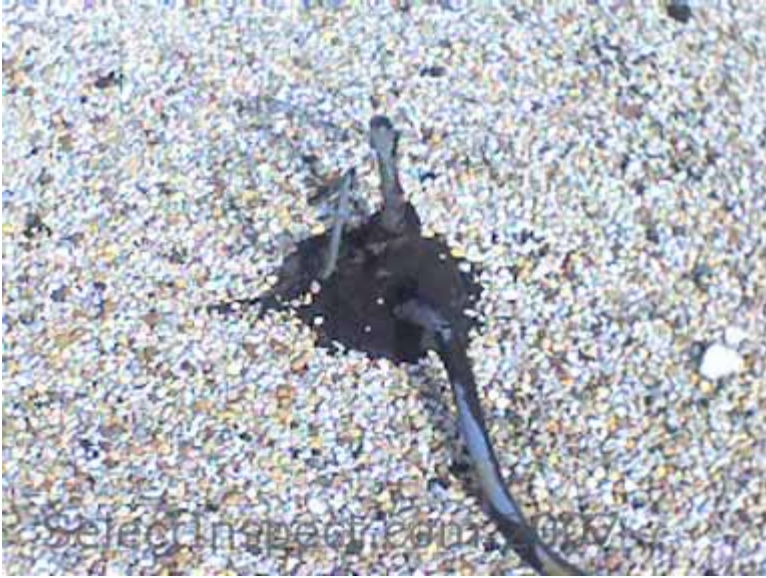
↑ rooftop air-conditioner condenser removed- refrigerant and electrical components remain

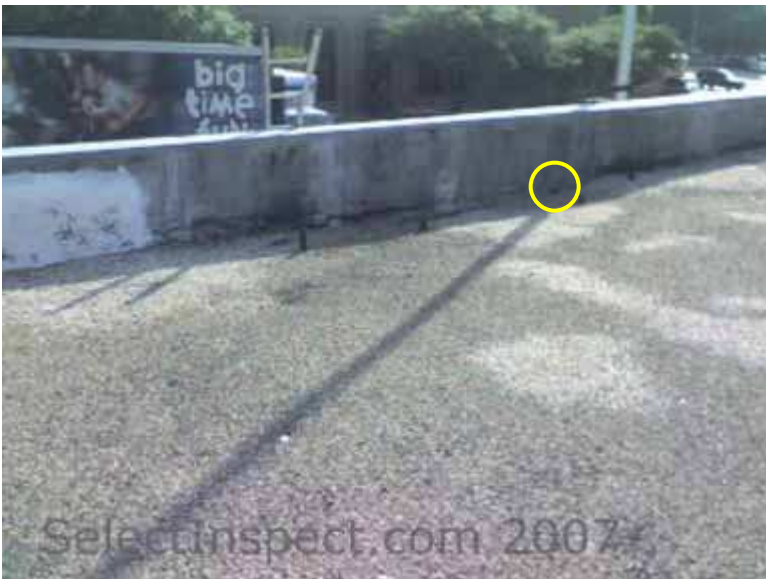
↑ poor drainage at roof- scupper location not at lowest point

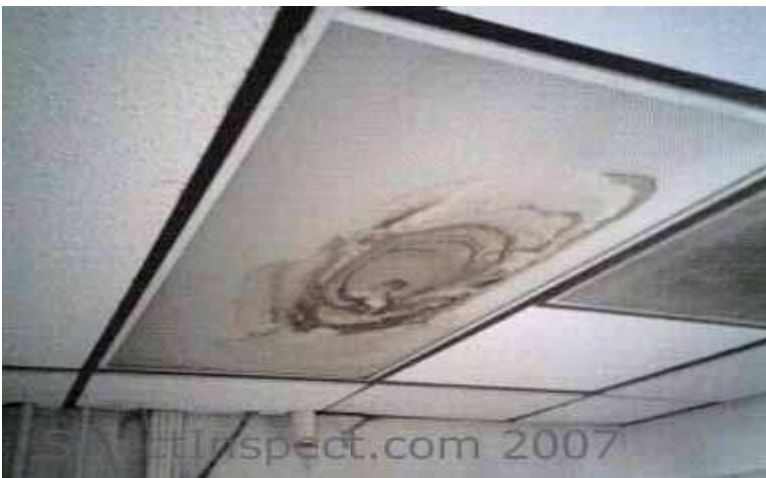
↑ moisture intrusion at light fixture in northeast room- below HVAC (related: image #1 page 12)

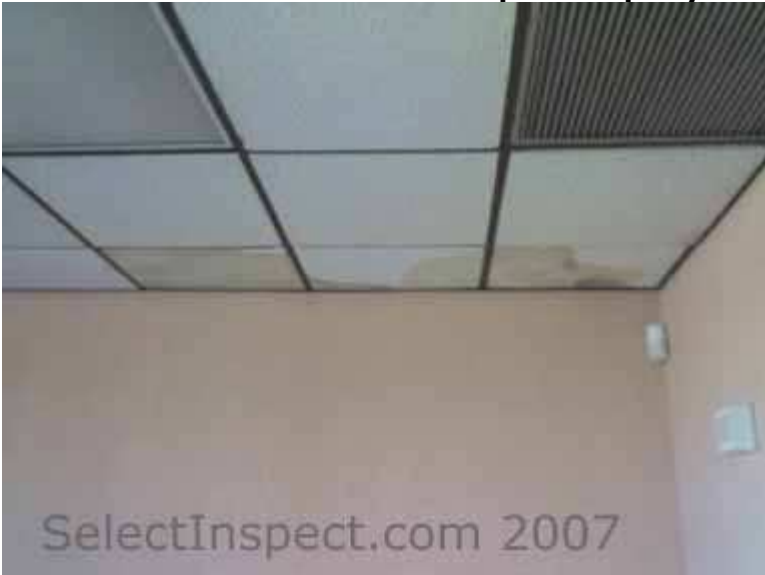
↑ moisture intrusion at main room- northeast

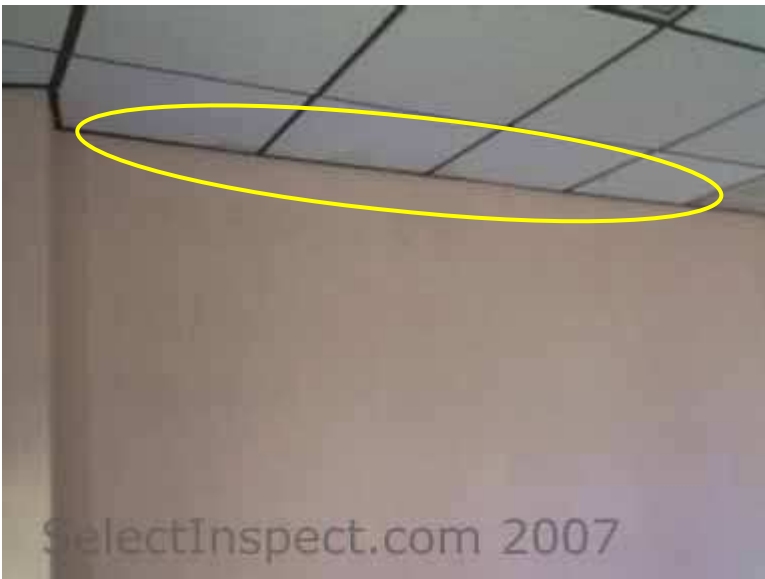
↑ moisture intrusion at main room- north

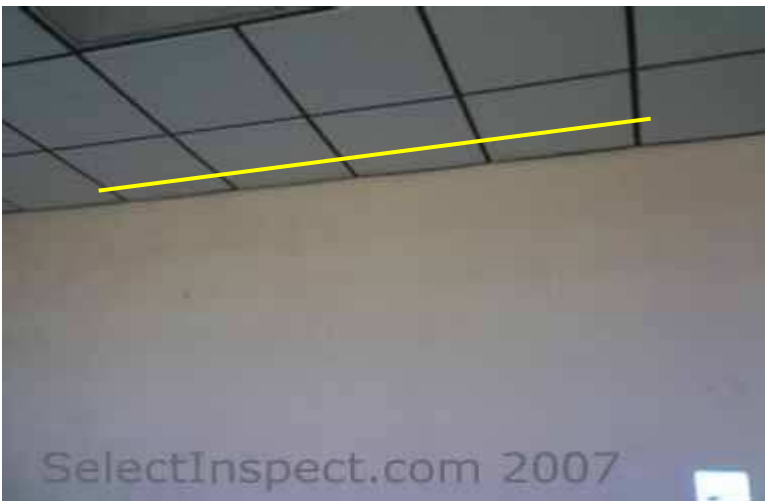
↑ moisture intrusion at main room- east – below ducting

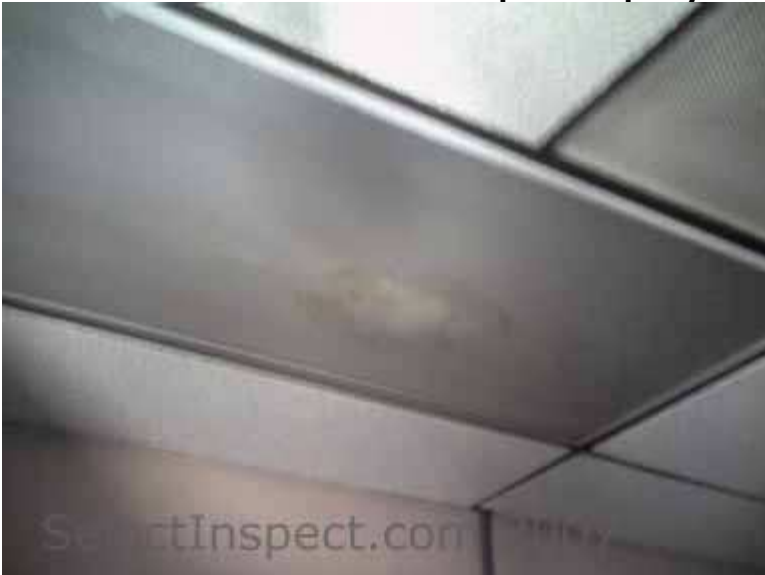
↑ moisture intrusion at light fixture in bathroom

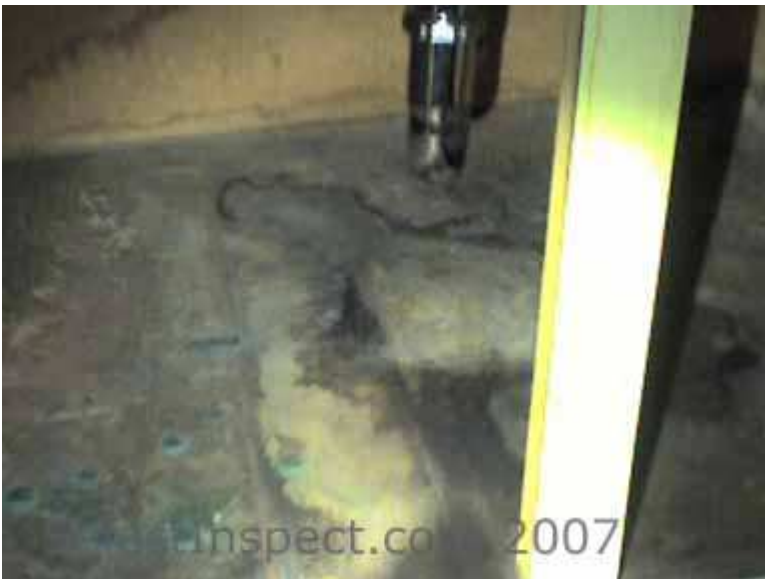
↑ moisture intrusion / fungus under breakroom sink

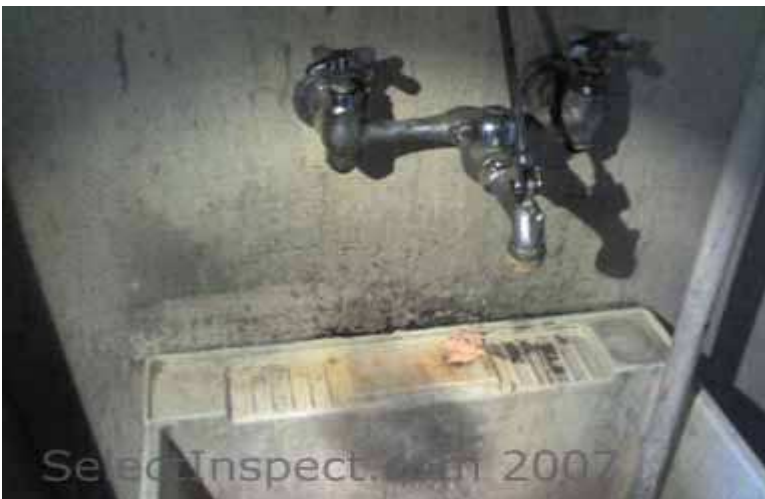
↑ moisture intrusion / fungus and damage at mop room wall

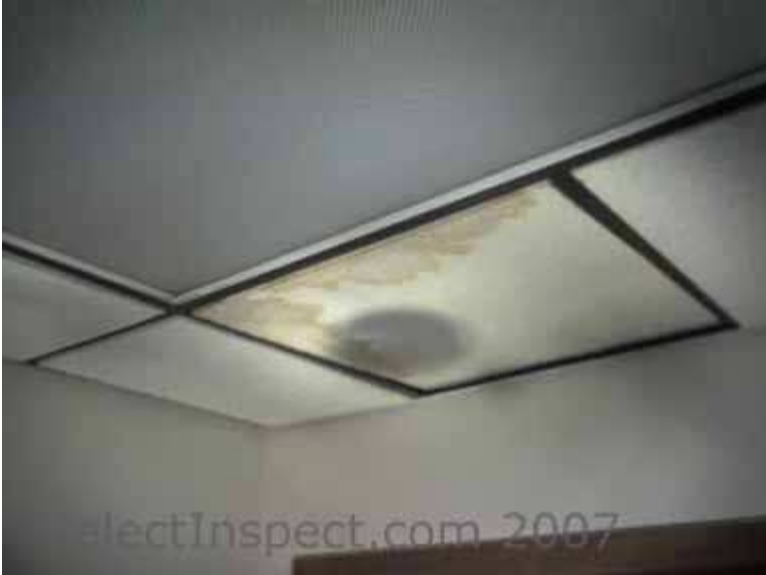
↑ moisture intrusion / fungus at secondary room

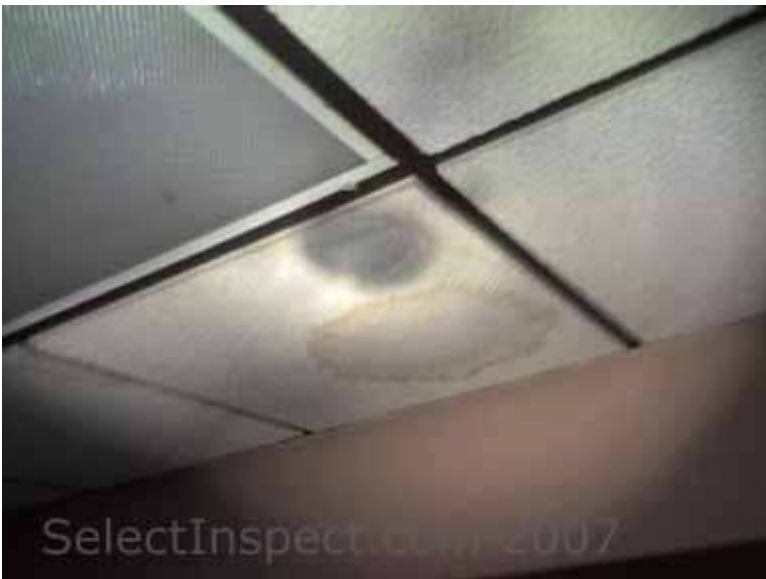
↑ moisture intrusion / fungus at secondary room

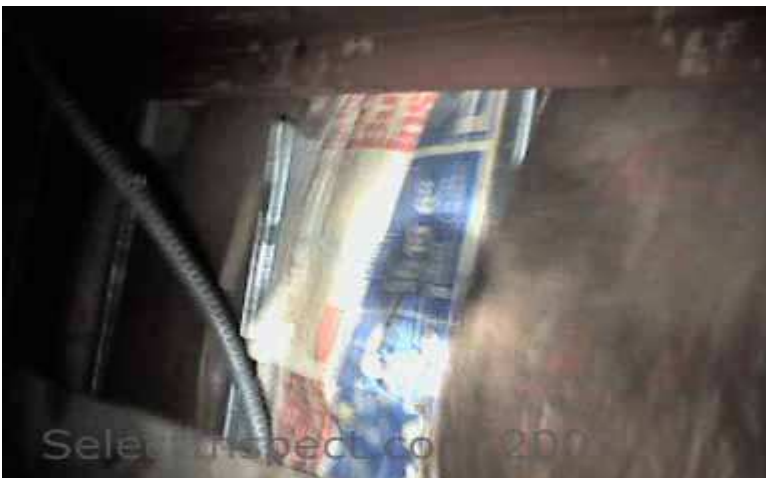
↑ moisture intrusion at perimeter insulation- ceiling crawl space

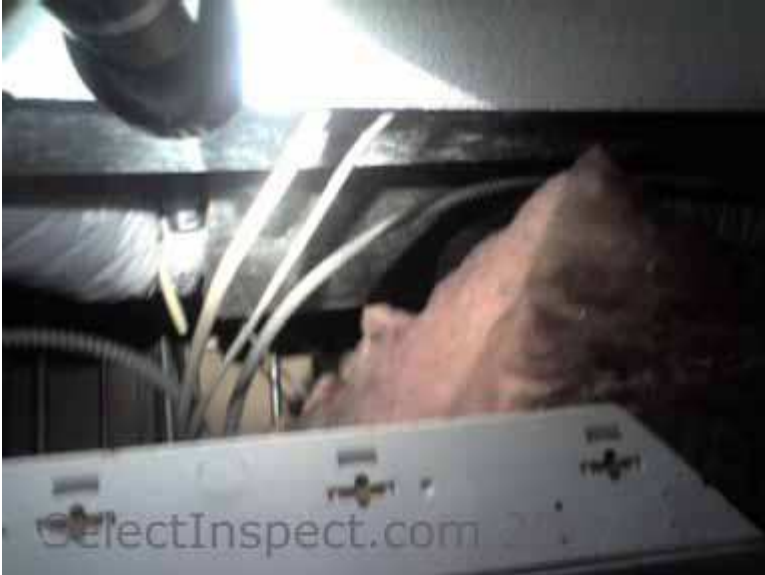
↑ underside of north HVAC in ceiling crawl space- above light fixture (related: image #3 page 8)

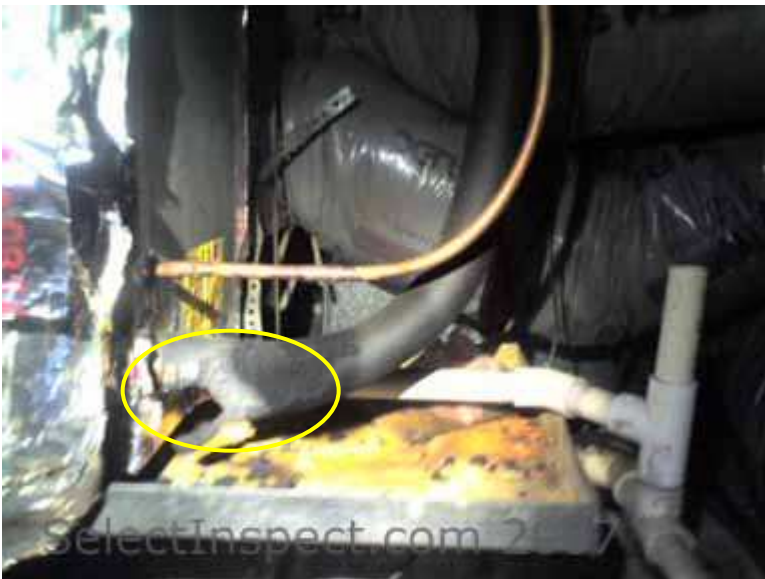
↑ rodent damaged refrigerant insulation and auxiliary pan corrosion at south HVAC / evaporator

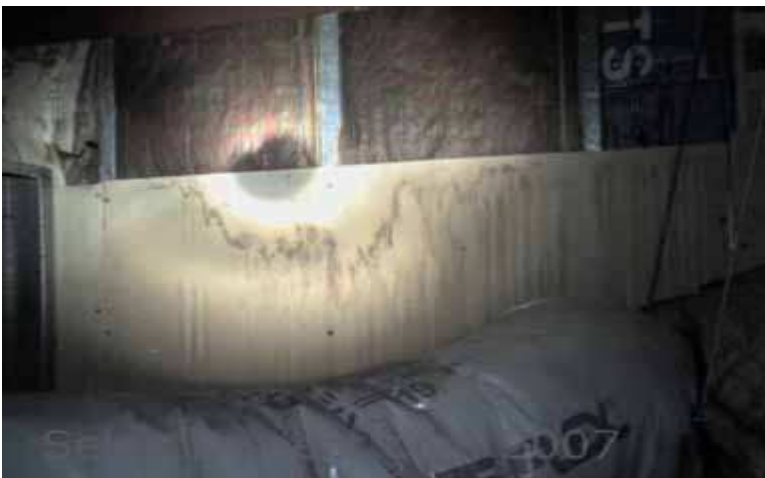
↑ moisture intrusion / fungus at east-southeast perimeter in ceiling crawl space

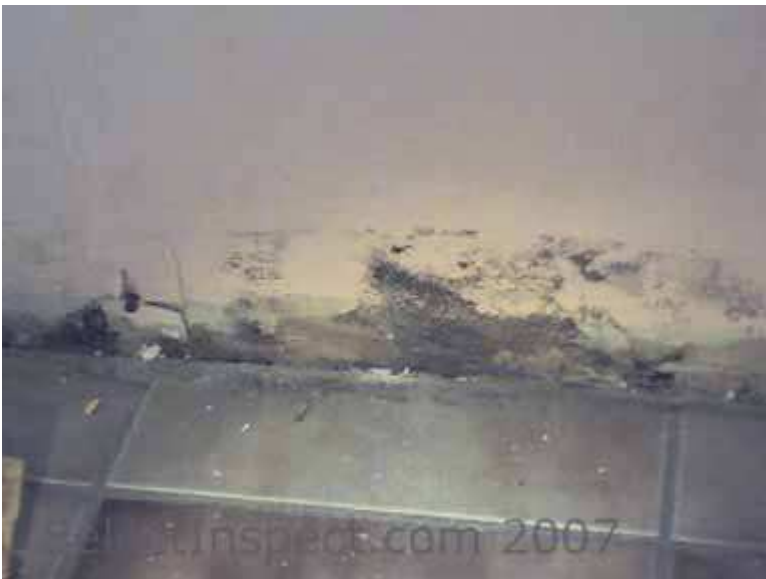
↑ moisture intrusion / fungus at west lower wall- main room

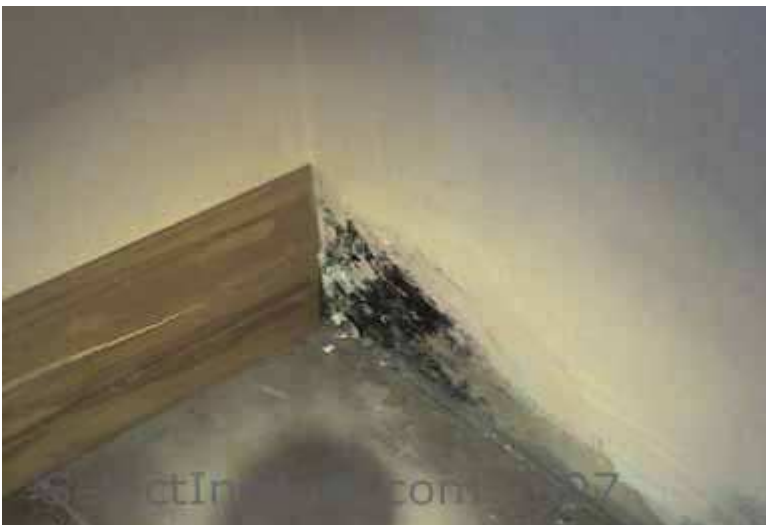
↑ moisture intrusion / fungus at north lower wall- main room
