PROPERTY CONDITION REPORT- PCR

| Address: | <b>123 Business Street</b> | | |
| City: | <b>Arlington</b> | State: | <b>TX</b> |

| Property Description: Light Industrial Warehouse Office | | | | | | |

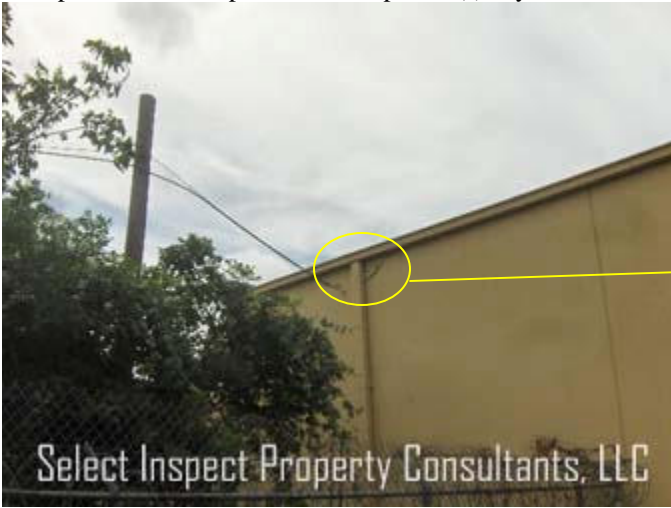
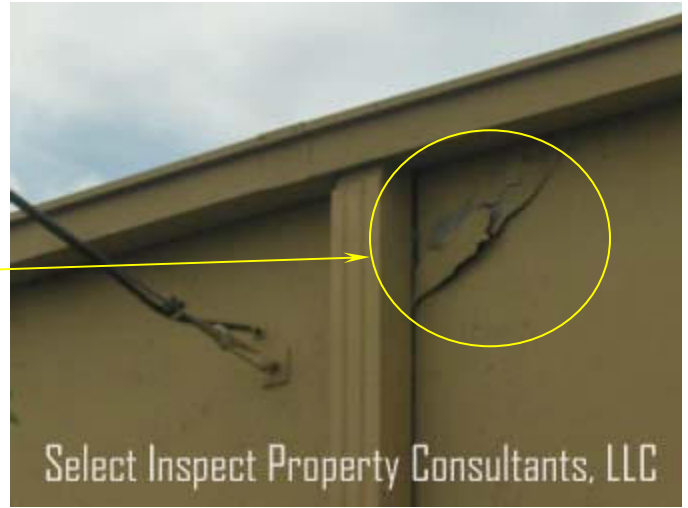
- Tiltwall cracks noted at the east & south southwest
- Cracks were noted above & adjacent the east (unused) dock areas. The east-northeast dock component(s) were corroded & the concrete stained. Recommend rust inhibitive coatings at the steel & sealant at adjacent concrete to reduce continued degradation
- Crack repairs exist at the south-southwest Refer to the seller for a time frame of when painting was last done, and you will have some baseline for how recent the cracking has occurred.
- Upper northeast (seen from the north, near the rear fence) tiltwall has cracked at the corner. Recommend this be examined & patched appropriately.
- The south including the shop & conditioned warehouse area appeared to be an addition to the original structure. Differential/unusual movement of the structures was not evident; Monitor; provide routine service, and maintain.

↑ cracked wall at the northeast

↑ close view of image at left

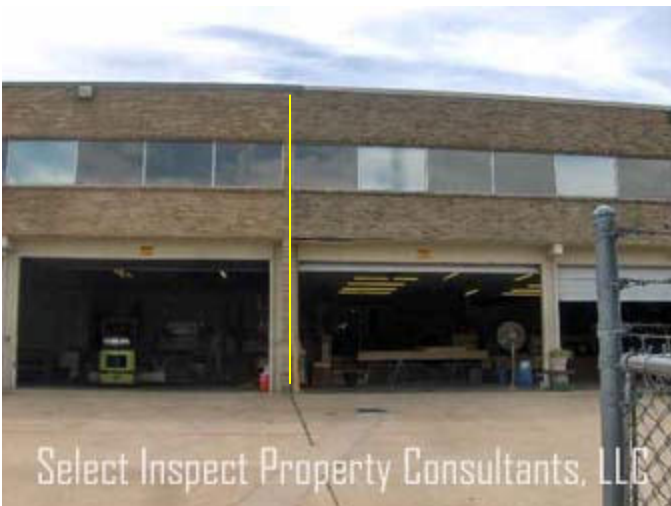
↑ structural addition implied by variant tone of brick & roofline & driveway control-joint

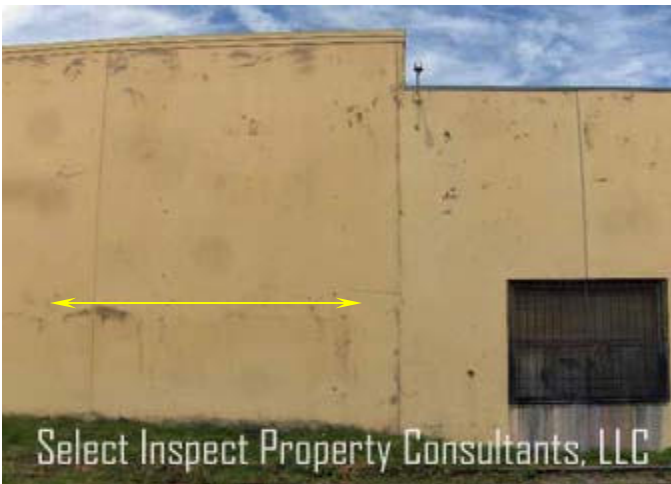
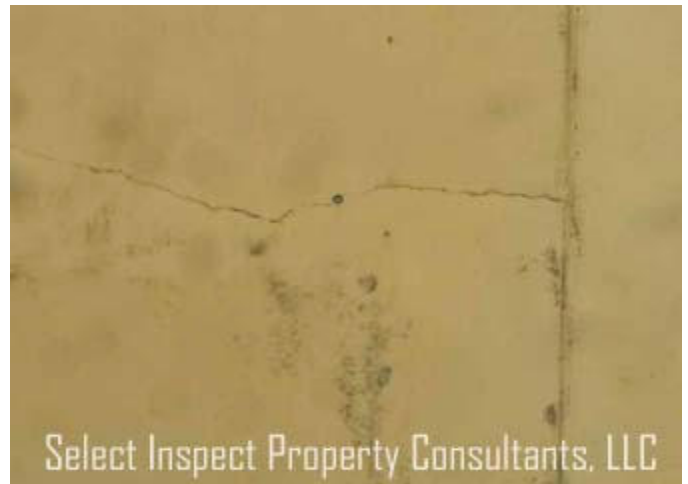
↑ stress cracks at the east

↑ close view of image at left

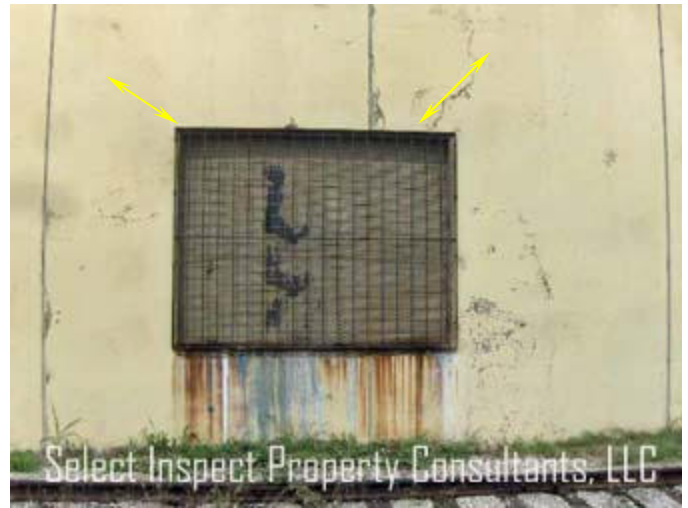
↑ stress cracks & deteriorating concrete & steel

↑ close view of image at left

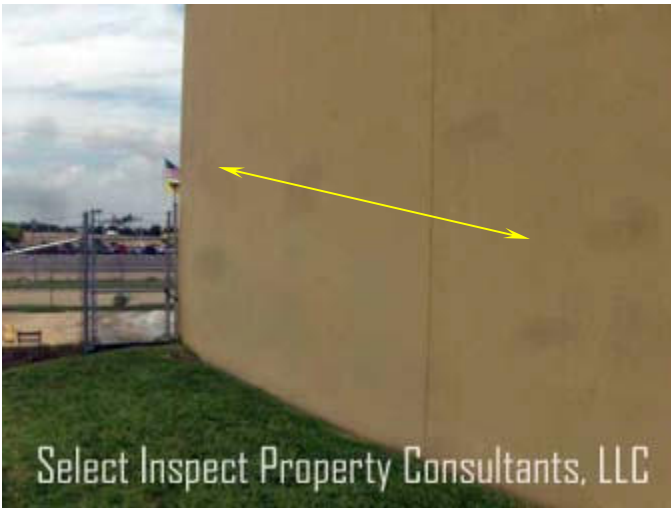
↑ stress cracks at southwest; sealed; Monitor; provide routine service, and maintain

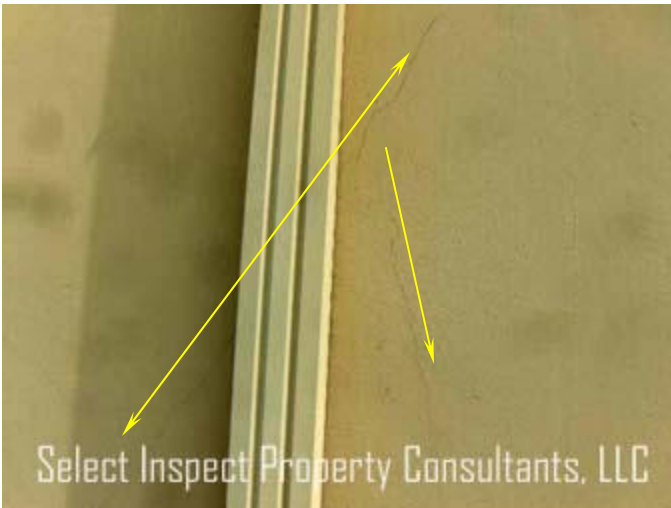
↑ stress cracks at southwest

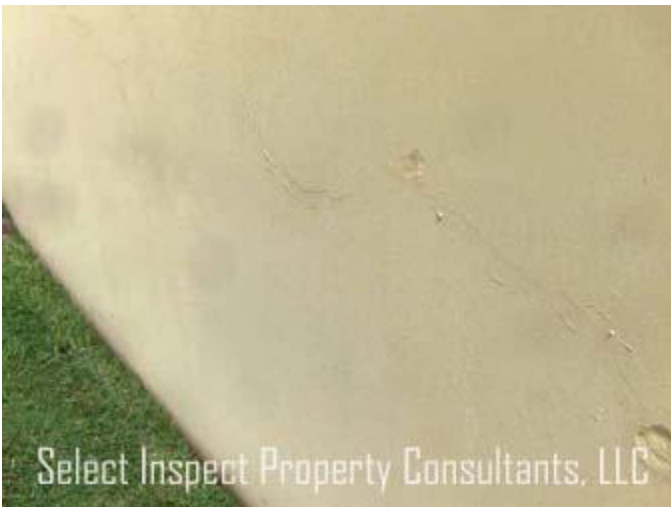
↑ stress cracks at southwest; sealed; Monitor; provide routine service, and maintain

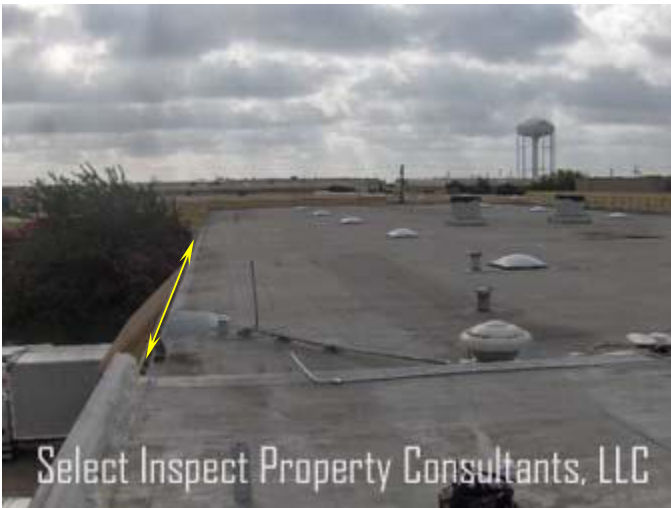
- Gutter at the north (above the main loading dock) had sags & did not properly slope for adequate drainage of rain \*& air conditioning condensate

↑ inadequate slope & drainage of gutters at north

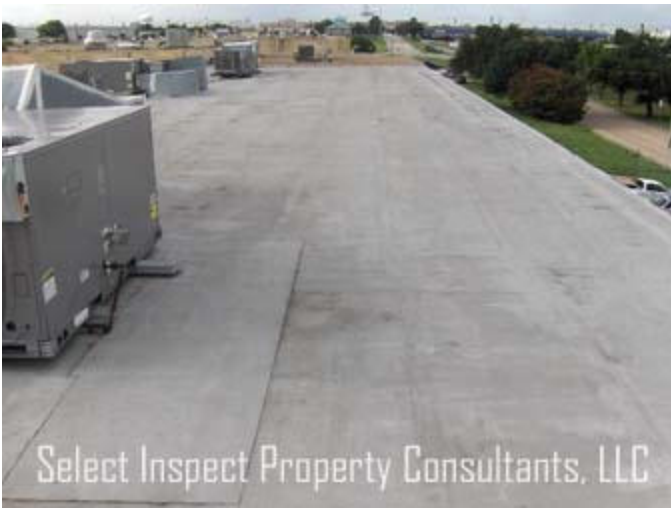
↑ office roof; workmanlike/in good order

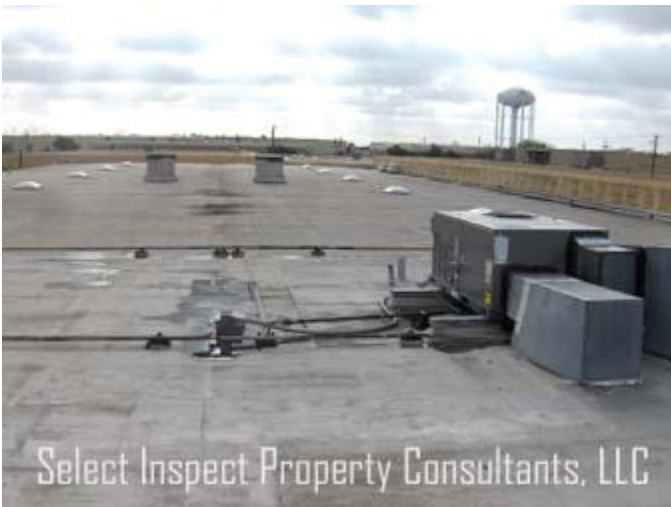
- Overall, the roof was workmanlike/in good order. There were areas that did not slope adequately toward scuppers or gutters for proper drainage of rain \*& air conditioning condensate

↑ warehouse roof; generally good condition, with some areas of inadequate slope

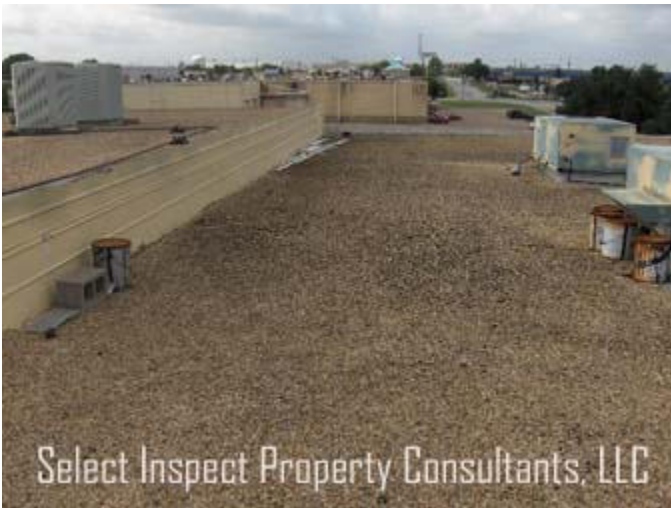
↑ shop roof; workmanlike/in good order; Monitor; provide routine service, and maintain.

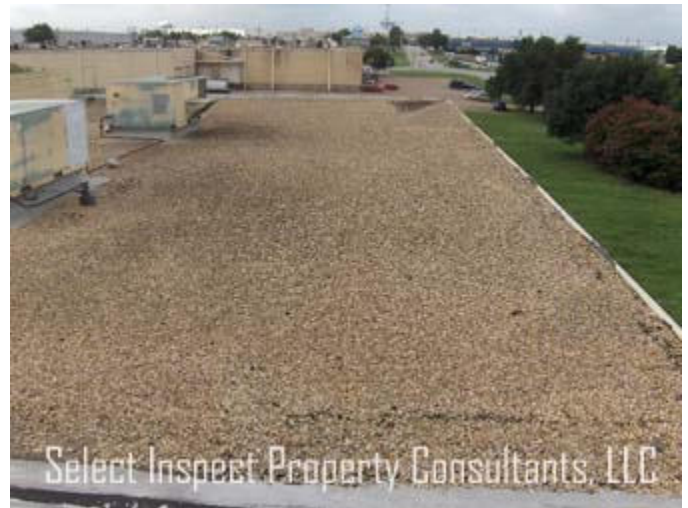
↑ shop roof front; workmanlike/in good order; Monitor; provide routine service, and maintain.

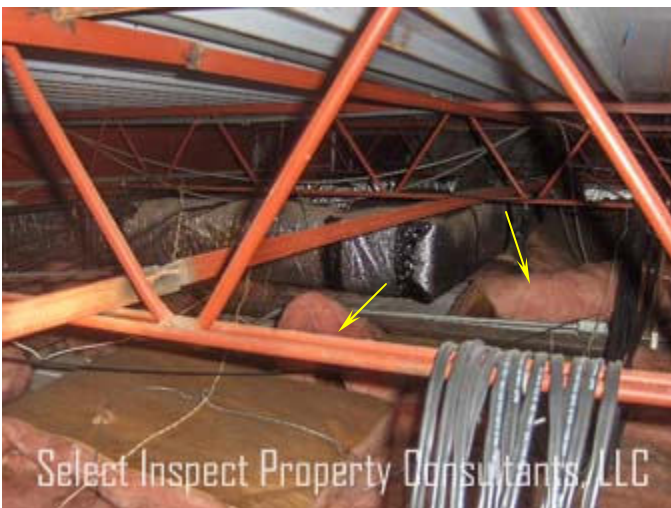
Insulation was deficient at various locations seen above ceiling drop tiles above the office & between levels. Moisture staining & corrosion was noted at drop ceiling grid in the gallery; active leakage was not discovered, though the air duct above has a small hole; suspected condensate leakage history. This air system was not currently being used, & the condensate leakage could return if the system is used again in the future.

↑ insulation between levels was amiss; example

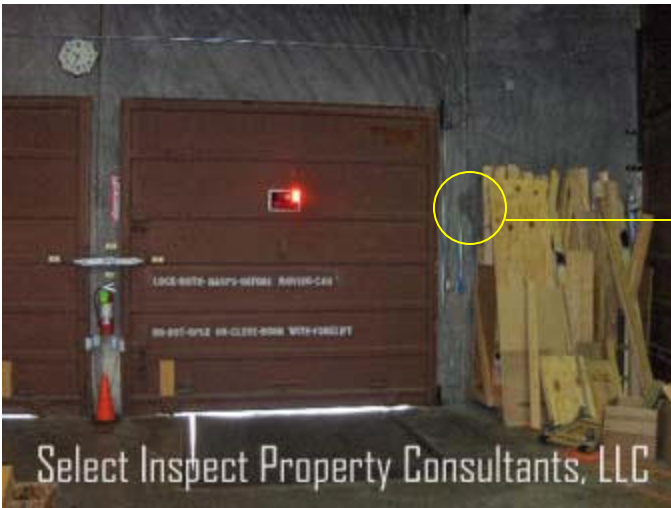
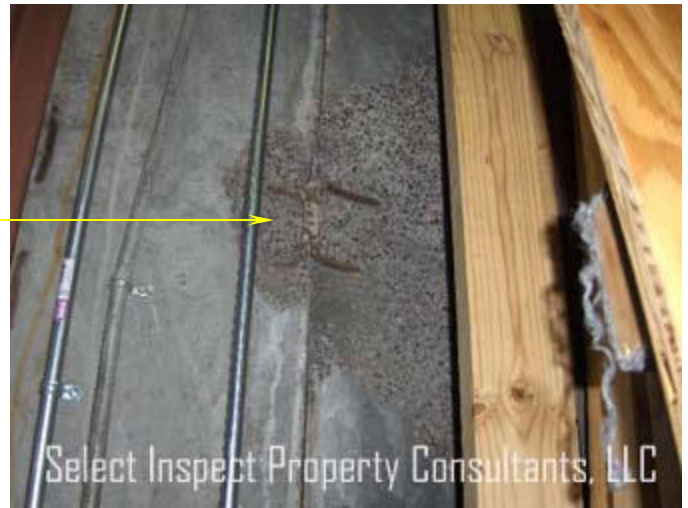
Central north dock bay doorway had a moderate section of concrete chipped/broken; steel reinforcement was exposed. The area should be patched & sealed to reduce risk of corrosion & degradation of the steel.

↑ chipped concrete wall & exposed reinforcement steel

↑ close view of image at left

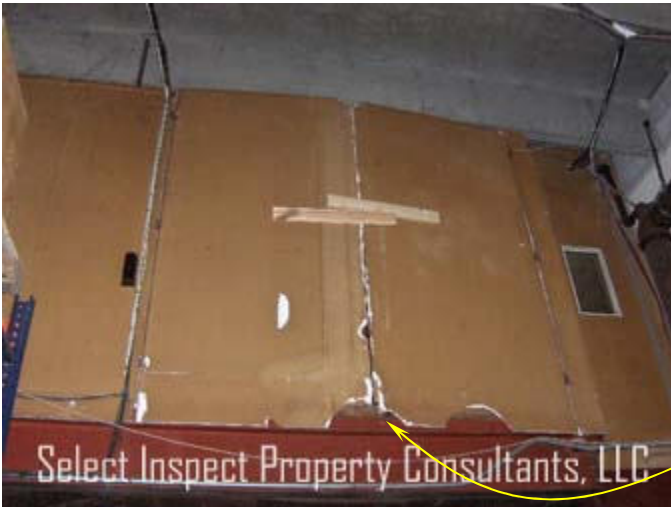
- Upstairs office closet adjacent the warehouse has “hinged walls” for access to install & remove large equipment/furniture upstairs; the hinged wall (door at the back of the closet) is unsteady & could pose a fall/injury risk for unassuming personnel.

↑ upstairs office closet has hinged wall; caution

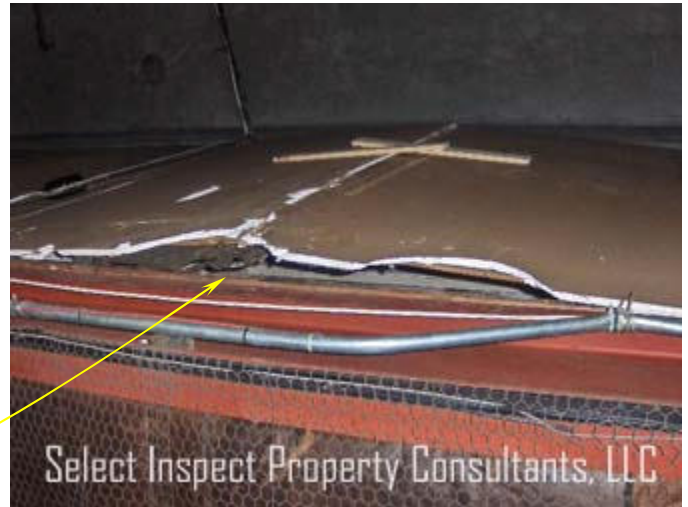
↑ unsteady/hinged wall viewed from below

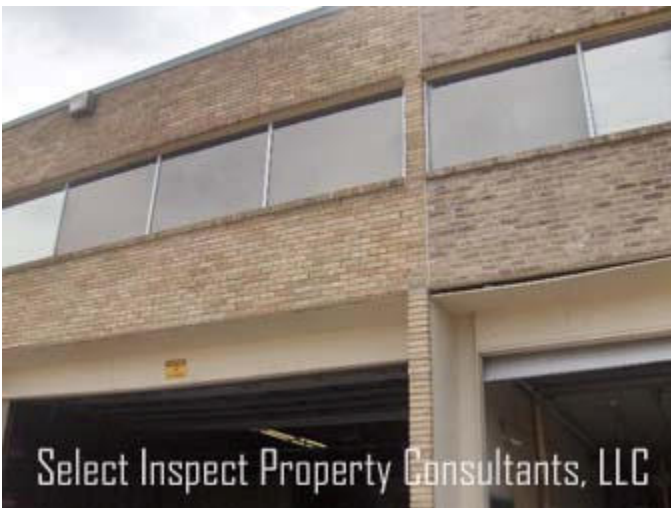
- Glass was broken at the upper office west-northwest & gallery west.
- NOTE: Some windows were partially inspected or had limited access, due to furnishings, lighting conditions, window treatments, etc. Some conditions may remain undetermined.

↑ cracked windows discovered at the gallery

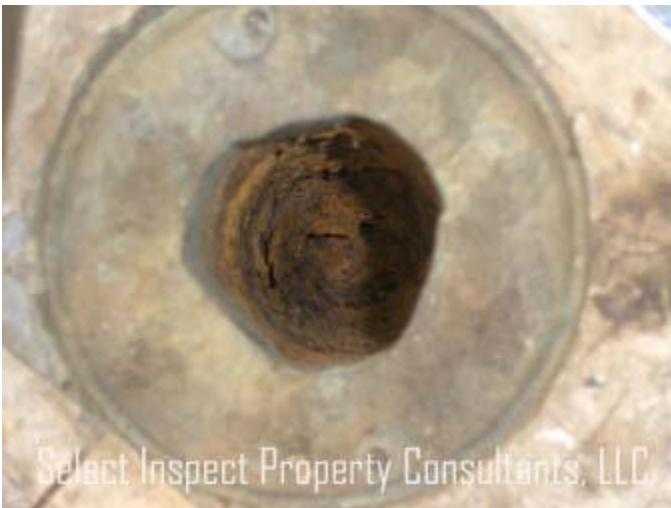
- Floor drain at the bar had excess corrosion; if this is to be used, you should have a plumber clean or change out the piping.
- Recommend a plumber arrange a pressure test if you have concerns with subgrade plumbing components

↑ excess corrosion within the upstairs bar floor drain.
