## Select Inspect Property Consultants

### Thermal Imaging Report

This service was provided regarding property at:  
876 North Street; Denton, TX 76209

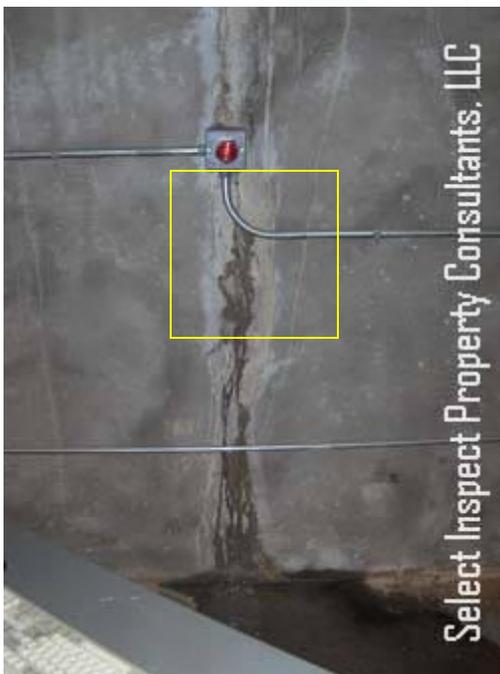
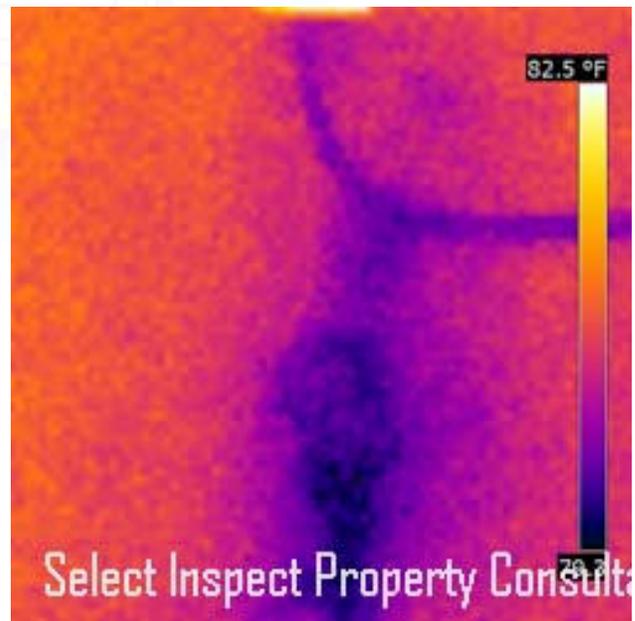
↑ Thermal imaging of image at left

↑ active moisture intrusion through the concrete wall at the west of VSAB-2

Recommend sub-grade drainage system be installed along the west foundation wall(s) with minimum slope of 1/4” per foot to terminate at a location where all water will be released & remain a minimum of 10 feet from the structure. if a drainage system is present, it apparently is not functioning as intended & would require replacement.

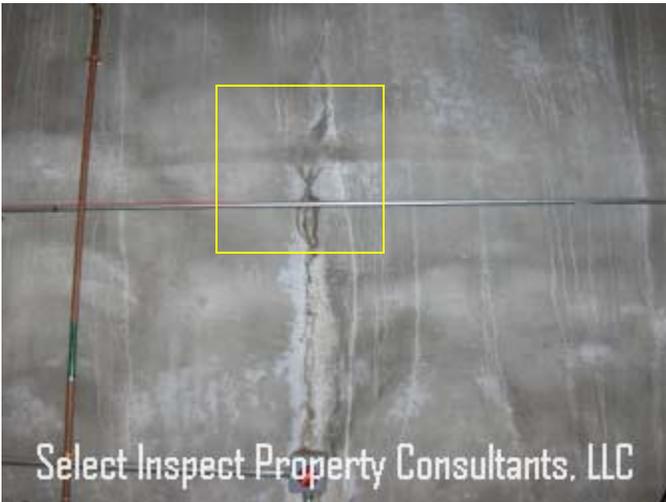
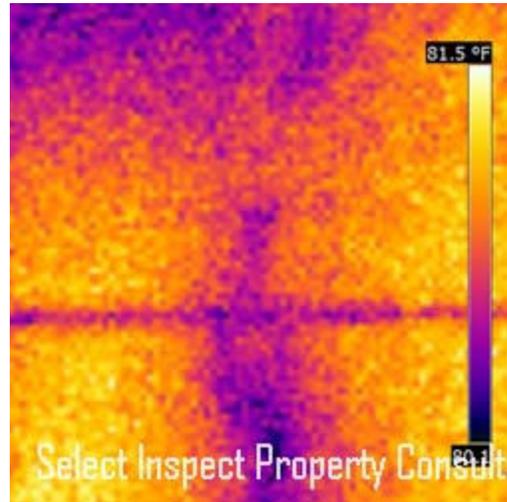
↑ active moisture intrusion through the concrete wall at the west of VSAB-2

↑ Thermal imaging of image at left

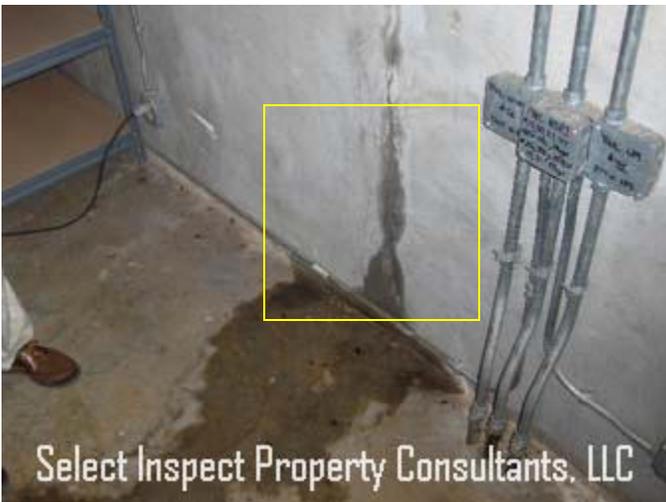
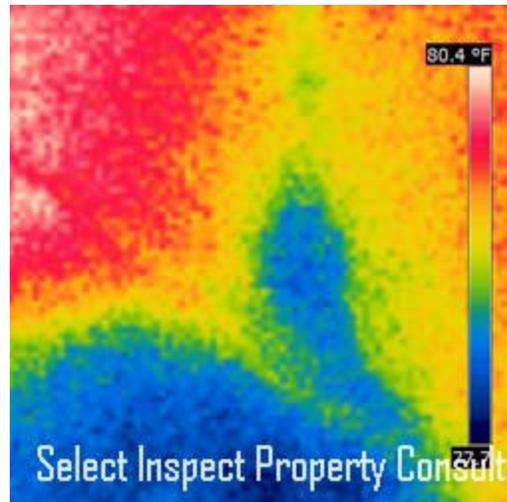
↑ active moisture intrusion through the concrete wall at the west of VSAB-2

↑ Thermal imaging of image at left

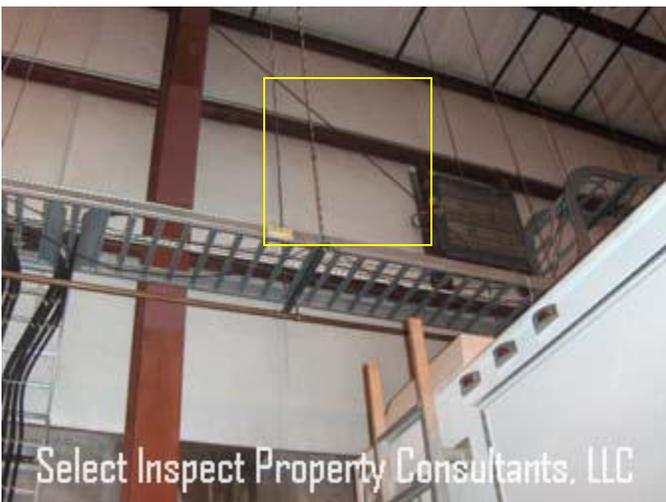
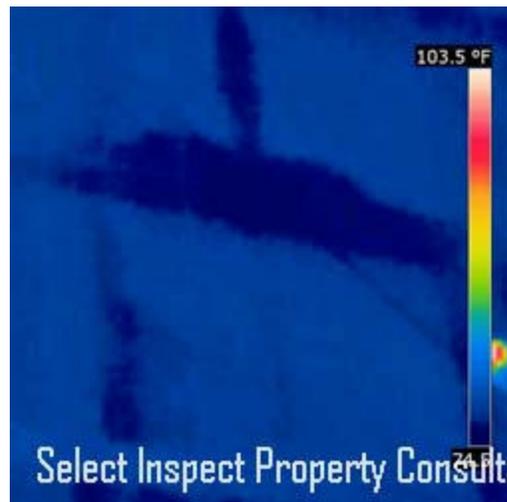
↑ active moisture intrusion through the ceiling/roof at the west-northwest of VSAB-2; water was seen dripping from the roof/ceiling, splashing & pooling atop the structural steel, & penetrating the insulated wall components

↑ Thermal imaging of image at left

Roof leaks were discovered at the west-northwest, central, & southern areas of VSAB-2; roof repair is necessary; extent of the conditions would require roof access during suitable weather conditions.

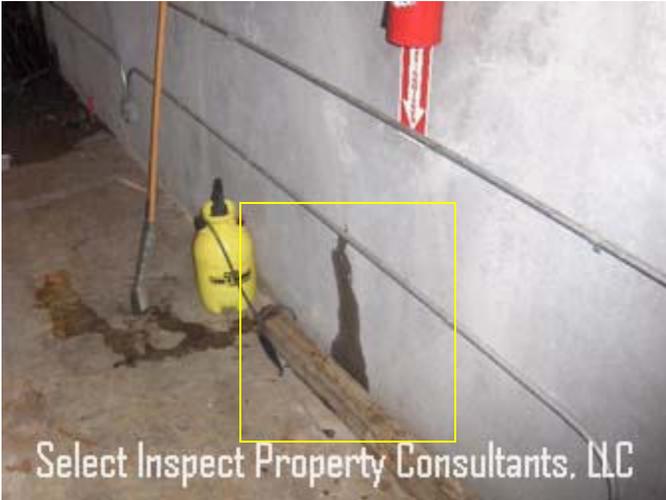
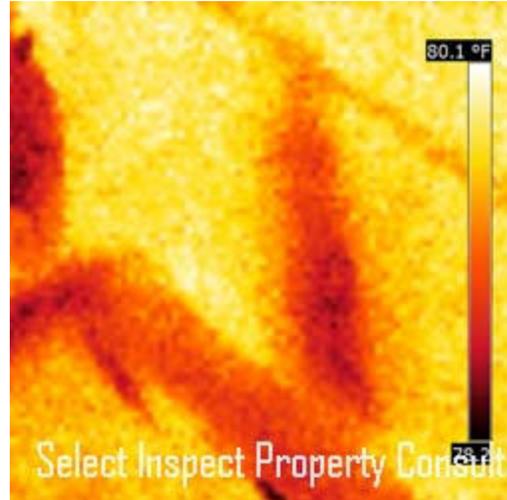
↑ active moisture intrusion through the concrete wall at the west of VSAB-2

↑ Thermal imaging of image at left

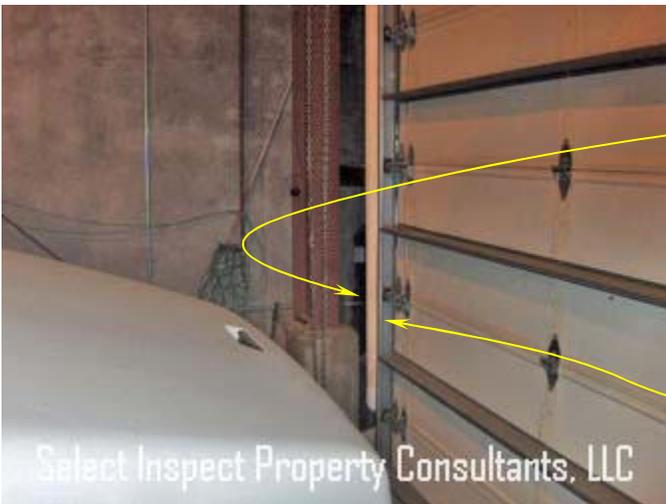
↑ active heavy water flow at the northwest corner of VSAB-2

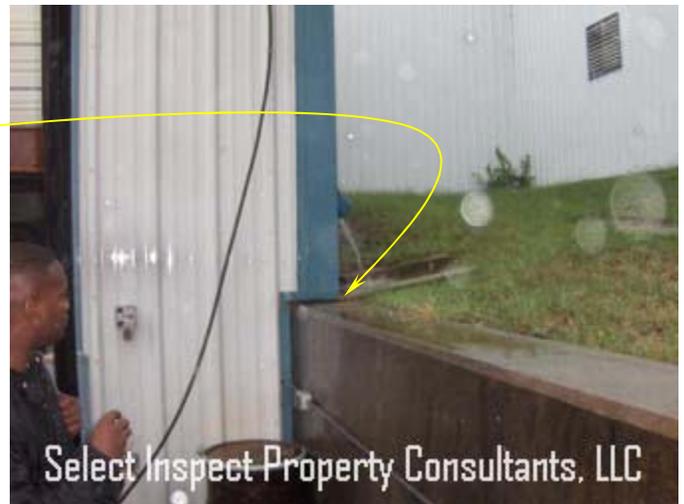
↑ (outside of image at left) negative grade; gutter down-spout termination toward negative slope, water returns to the inadequately sealed corner of the structure & enters the structure.

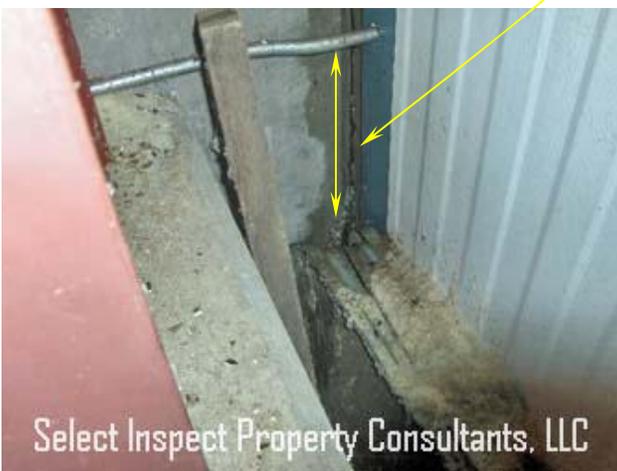
↑ close view of image above; inadequately sealed concrete/steel structure corner allowing significant moisture intrusion into the building.

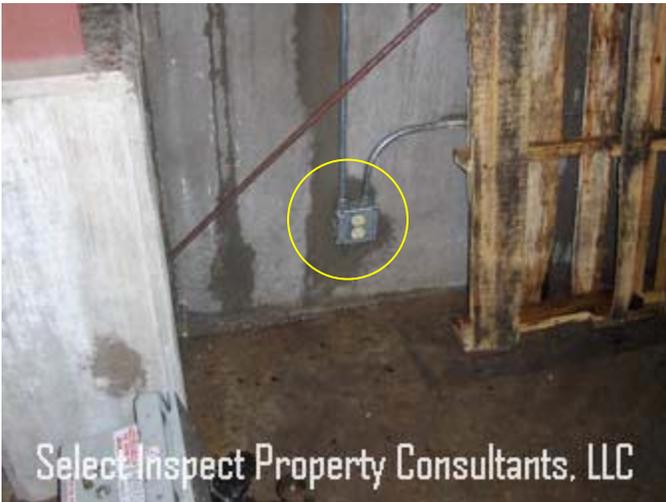
↑ moisture intrusion at / on / into electrical receptacle at west VSAB-2; potential fire hazard

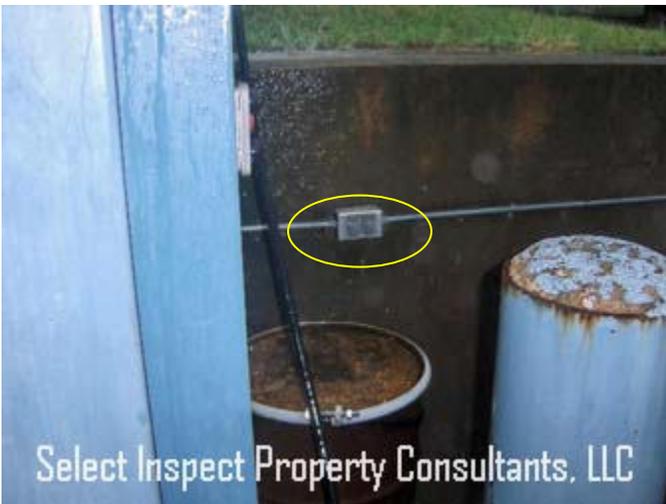
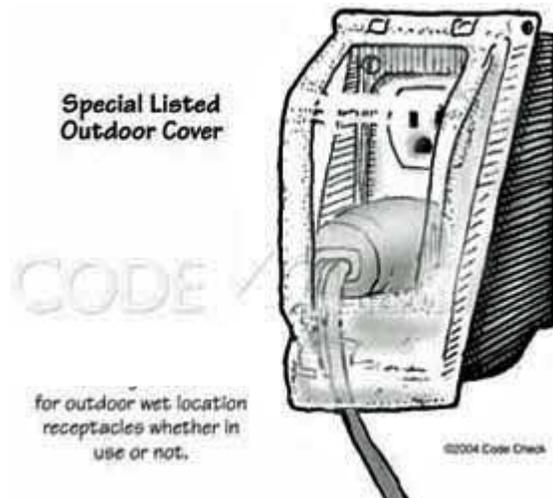
↑ electrical receptacles at exterior locations did not have currently approved “weather-tight” outdoor covers in place; recommend approved modern covers at all exterior locations that are not protected by eaves & all exterior receptacles lower than 6 feet from grade should also be ground-fault circuit interrupt (GFCI) protected.
