Select Inspect Property Consultants

Copyright 2008

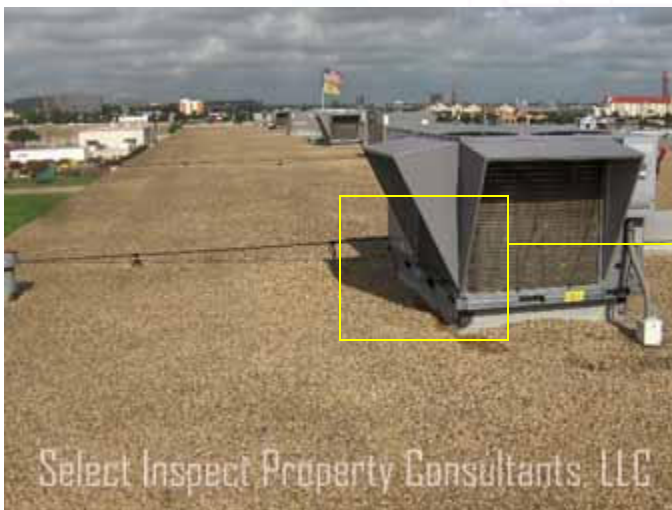
↑ air conditioning condensate leakage (& shadows) at southeast roof

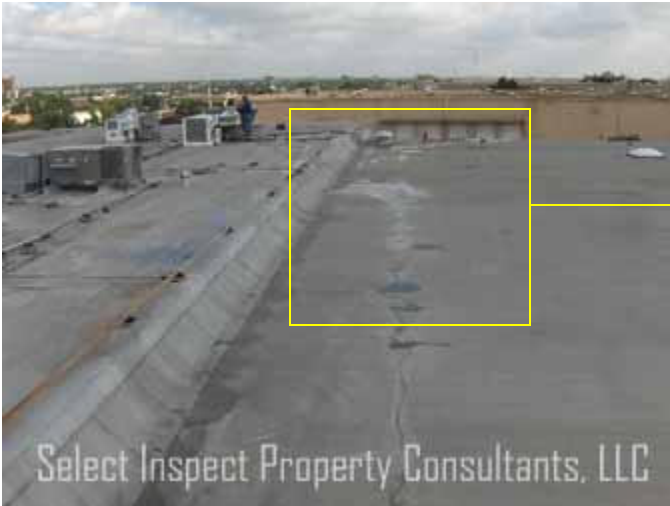
↑ air conditioning condensate; inadequate drainage from rooftop

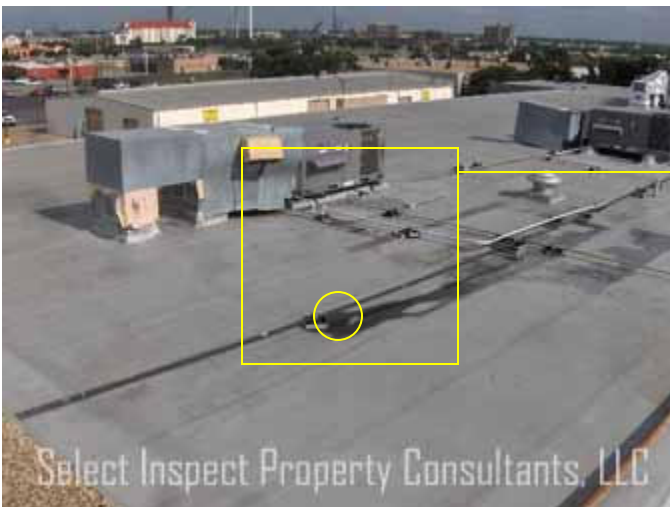
↑ air conditioning condensate; inadequate drainage from rooftop; leakage active at drain line (circled); damaged drain pipe was discovered; refer to your HVAC report for related information

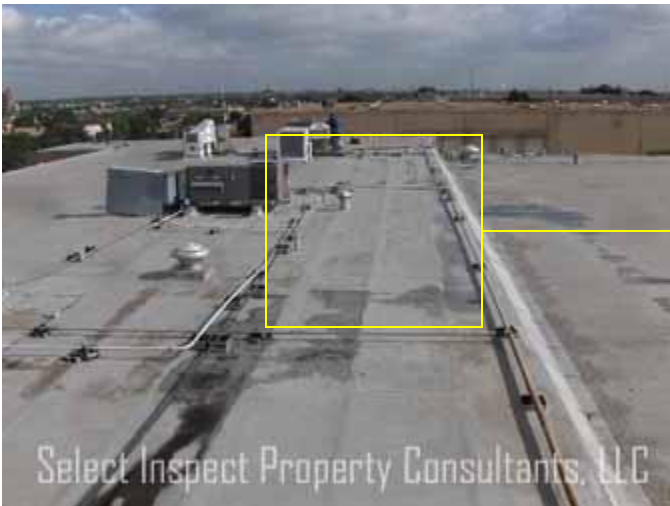
↑ air conditioning condensate; inadequate drainage from rooftop

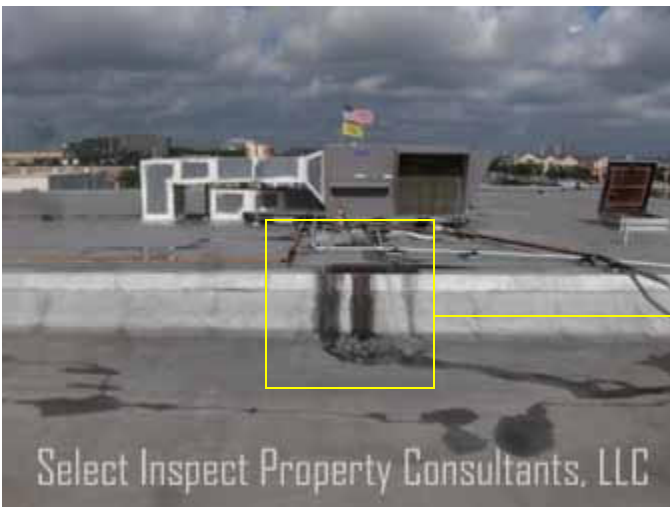
↑ air conditioning condensate; inadequate drainage from rooftop

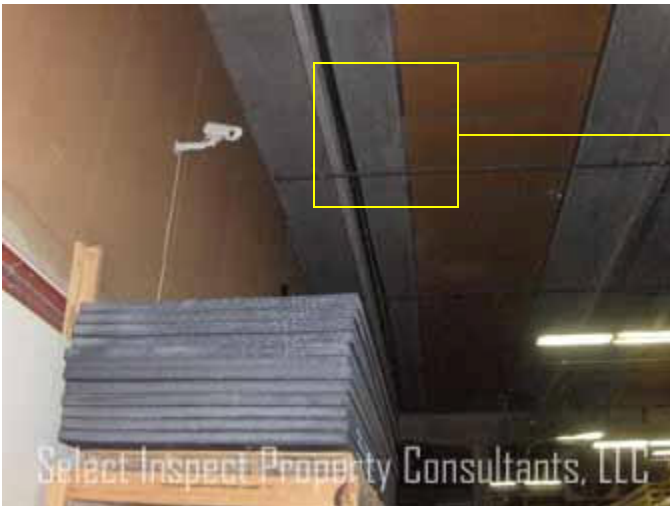
↑ warehouse west; below condensate leakage discovered at roof; adjacent the raised roof section between office & warehouse

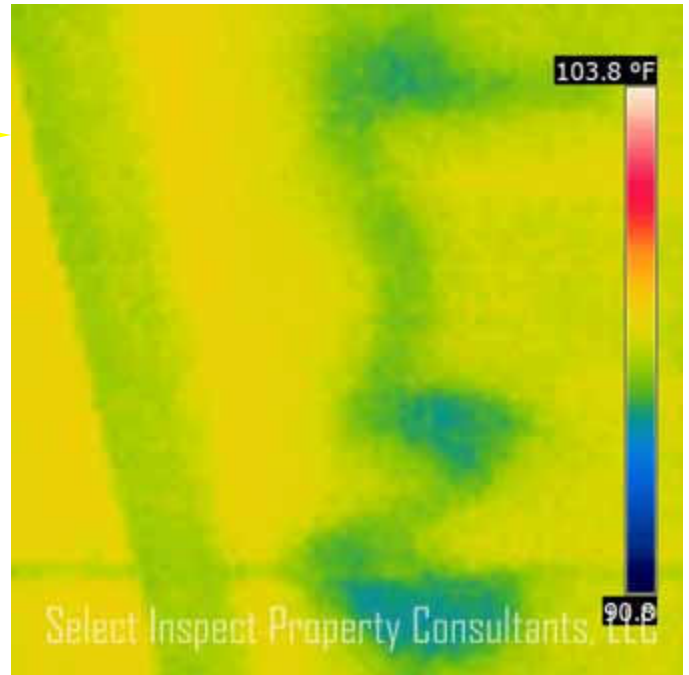
↑ cooler temperature implies leakage or "cool-down" from the cold moisture above. Concrete is porous & the stained ceilings imply at least a history of leakage

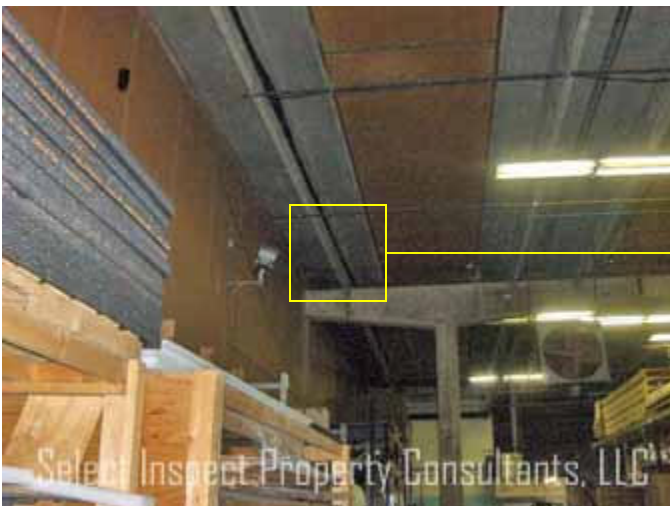
↑ warehouse west; below condensate leakage discovered at roof; adjacent the raised roof section between office & warehouse

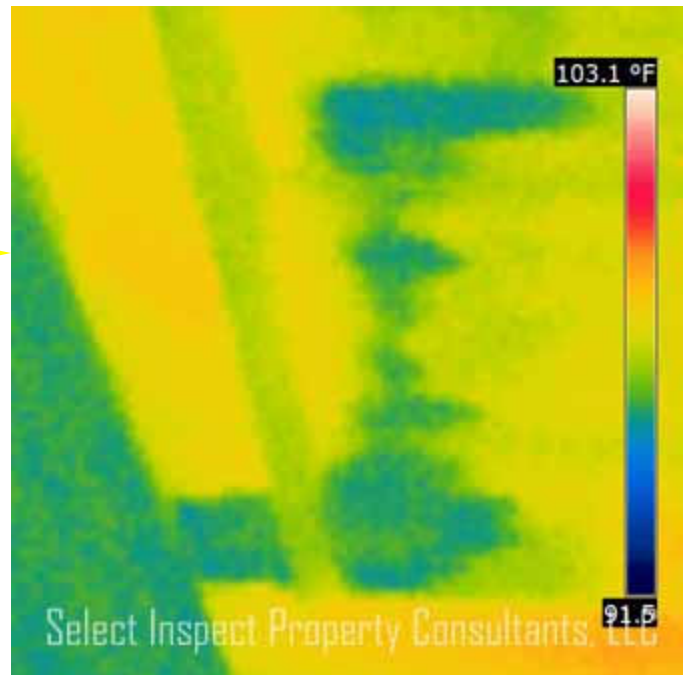
↑ cooler temperature implies leakage or "cool-down" from the cold moisture above. Concrete is porous & the stained ceilings imply at least a history of leakage

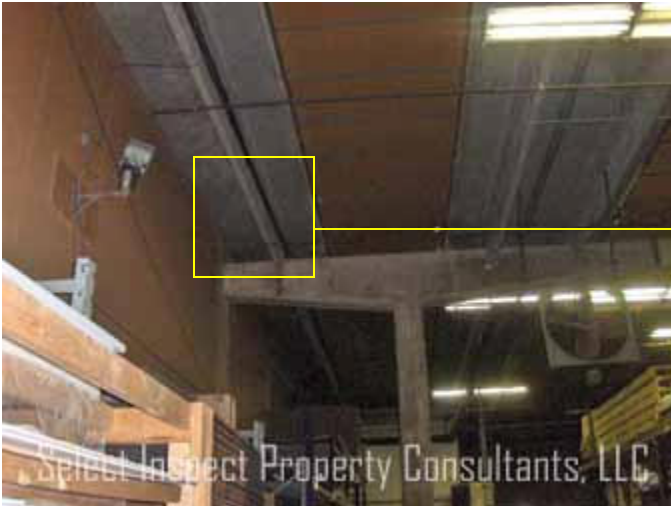
↑ warehouse west; below condensate leakage discovered at roof; adjacent the raised roof section between office & warehouse; same area as image above

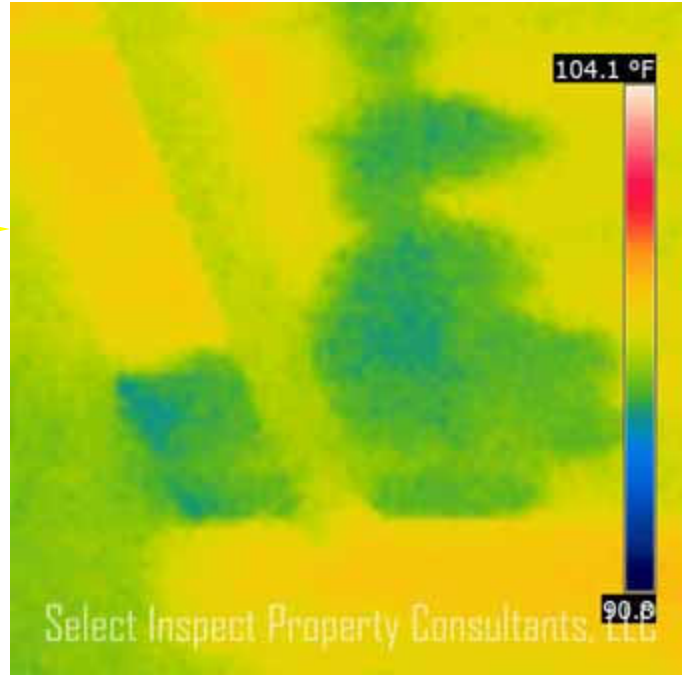
↑ cooler temperature implies leakage or "cool-down" from the cold moisture above. Concrete is porous & the stained ceilings imply at least a history of leakage

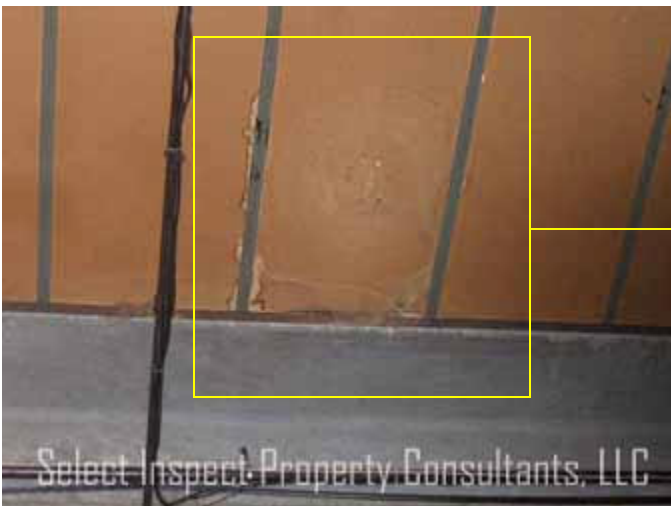
↑ warehouse west; below condensate leakage discovered at roof; adjacent the raised roof section between office & warehouse

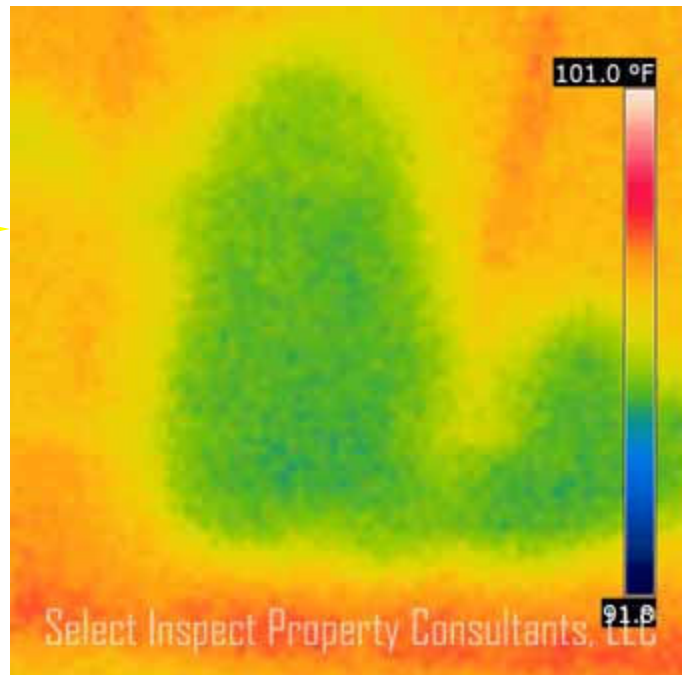
↑ cooler temperature implies leakage or "cool-down" from the cold moisture above. Concrete is porous & the stained ceilings imply at least a history of leakage

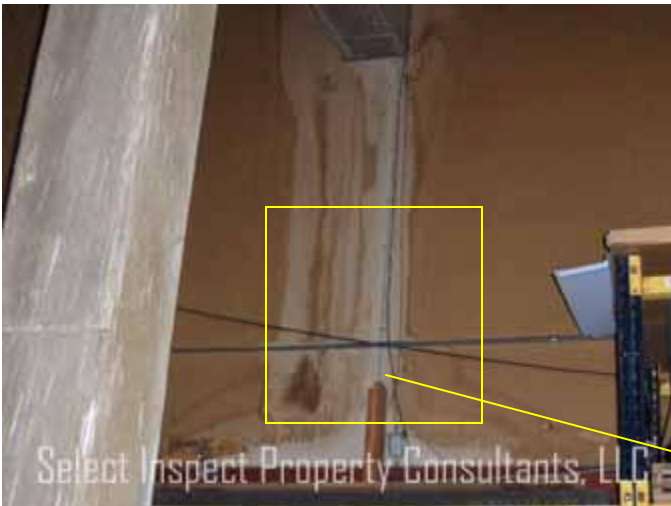
↑ warehouse west; below condensate leakage discovered at roof; adjacent the raised roof section between office & warehouse

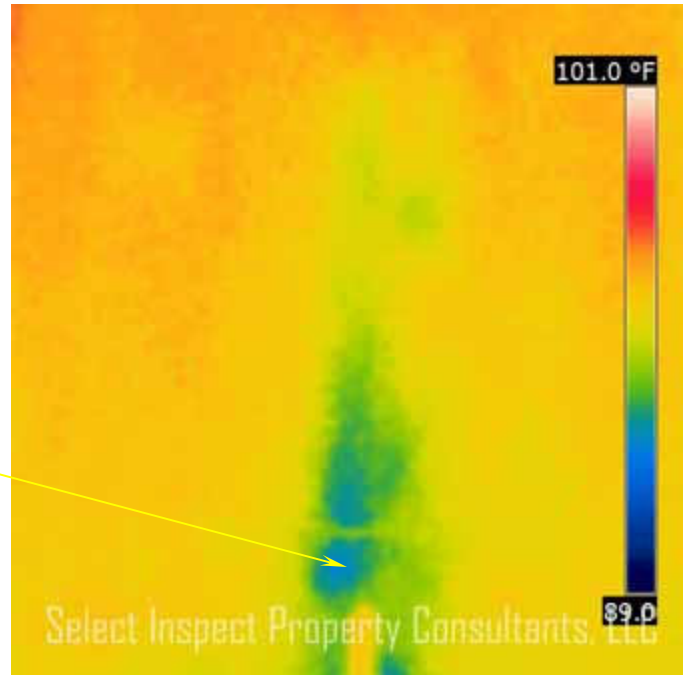
↑ cooler temperature implies leakage or “cool-down” from the cold moisture above. Concrete is porous & the stained ceilings imply at least a history of leakage

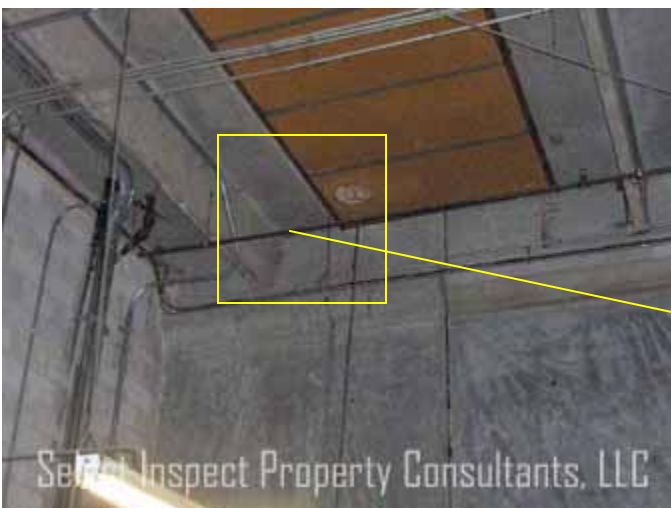
↑ warehouse west; below condensate leakage discovered at roof; adjacent the raised roof section between office & warehouse

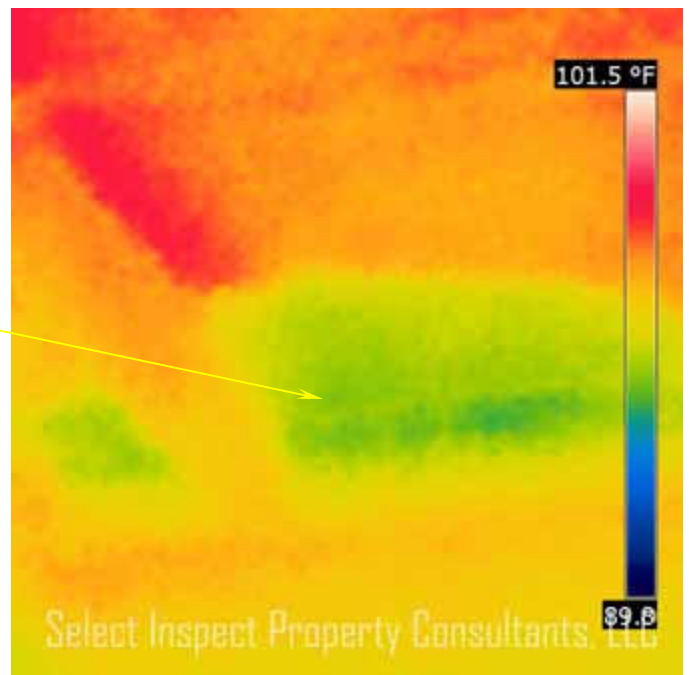
↑ cooler temperature implies leakage or “cool-down” from the cold moisture above. Concrete is porous & the stained ceilings imply at least a history of leakage

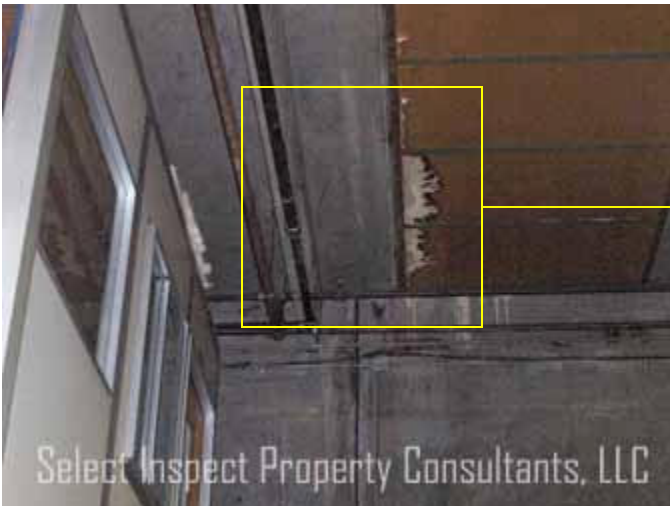
↑ warehouse northwest; stained ceiling, but Thermal imaging implies no anomalies; appears satisfactory

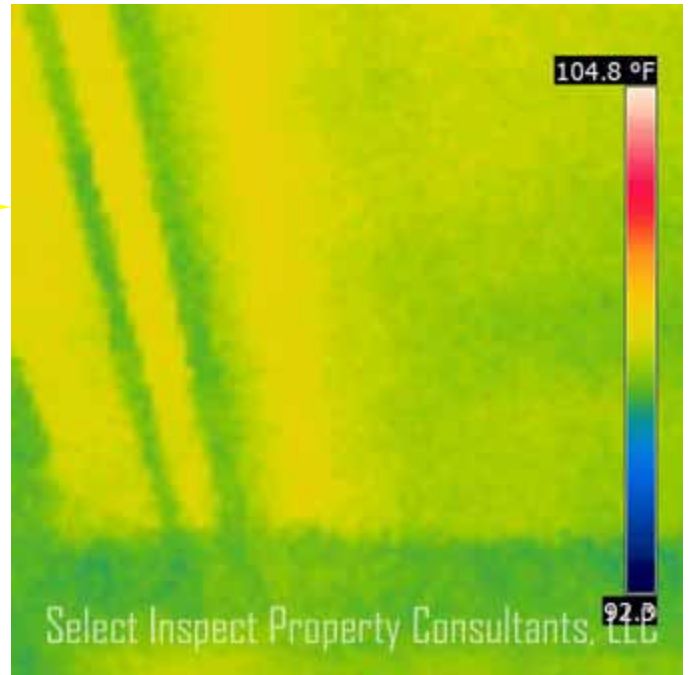
↑ leakage history; active moisture not discovered

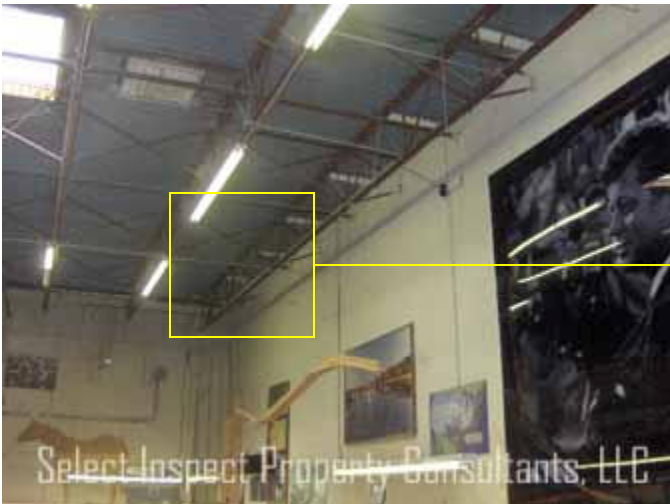
↑ workshop northeast; below condensate leakage discovered at roof; adjacent the raised roof section between office & warehouse/shop

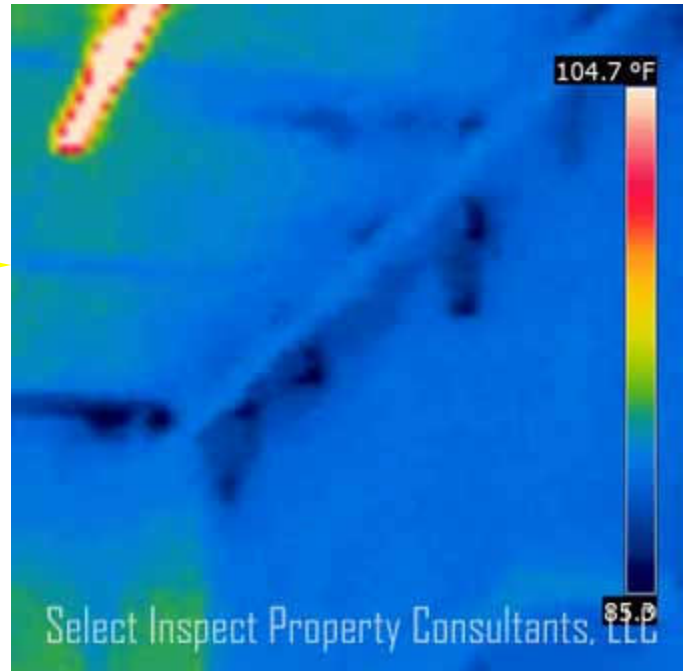
↑ cooler temperature implies leakage or "cool-down" from the cold moisture above. Considering the amount of condensate above, consider at least a history of leakage

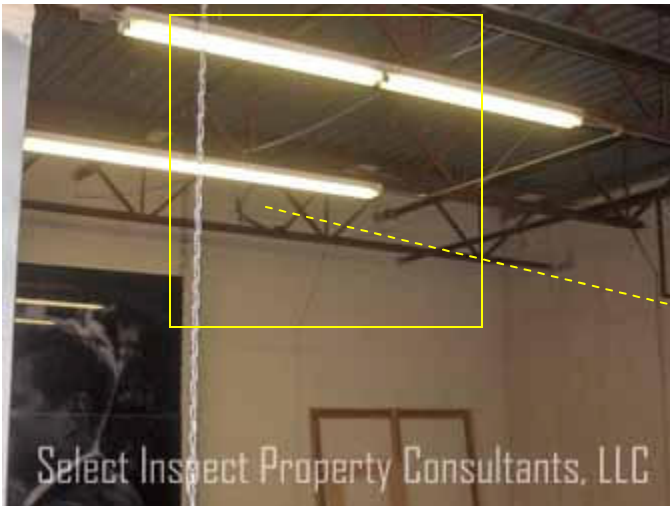
↑ workshop southeast; below condensate leakage discovered at roof; adjacent the raised roof section between office & warehouse/shop; (note: some of the "cool" items in this image appeared to be cold-water pipe & were not a concern (ie. right central, dark blue))

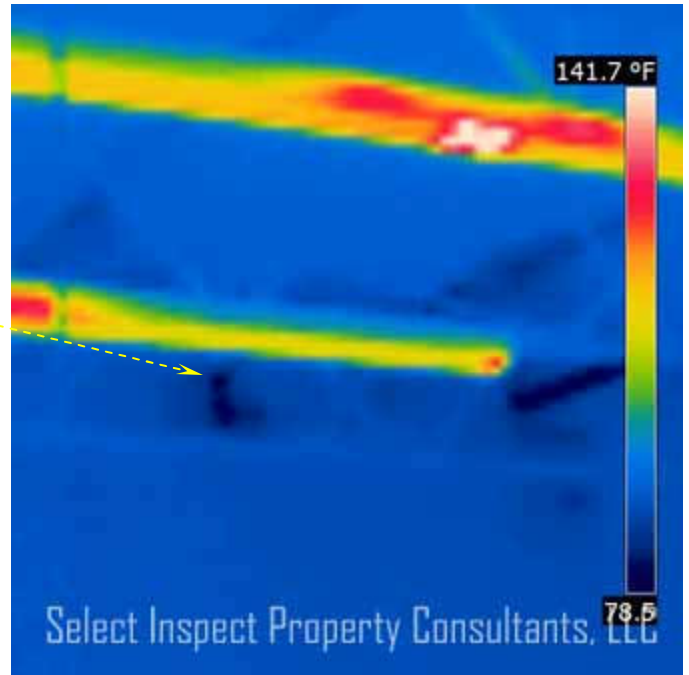
↑ cooler temperature implies leakage or "cool-down" from the cold moisture above. Considering the amount of condensate above, consider at least a history of leakage

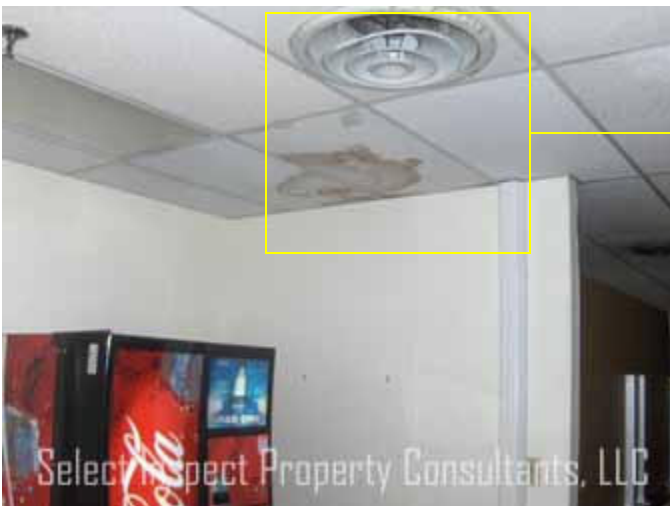
↑ stains at many office ceilings including the vending area appeared dry; satisfactory

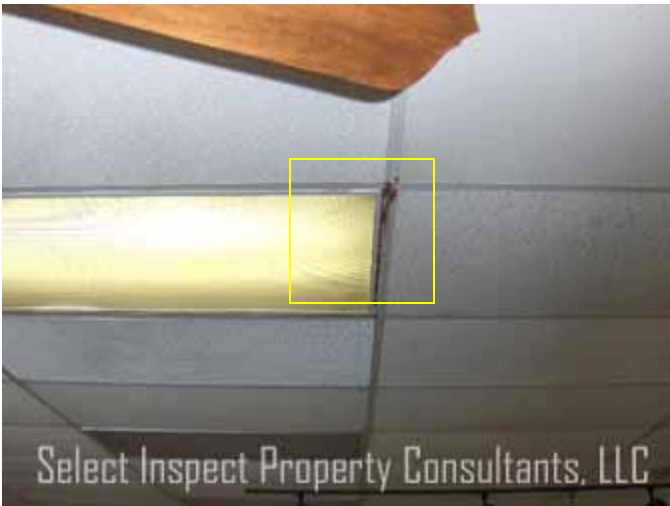
↑ corrosion & stains at the gallery ceiling; moisture not discovered, but deficient air ducting noted.

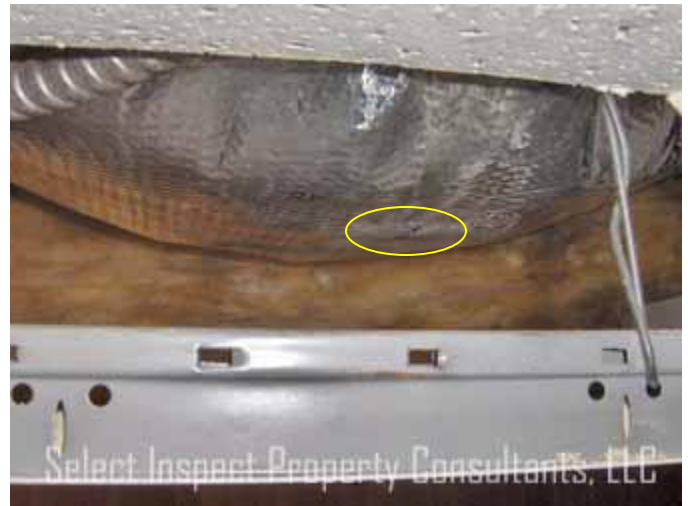
↑ above the image at left in the drop-ceiling; hole at air duct vapor barrier; system was off, but may still drip condensate if made operational

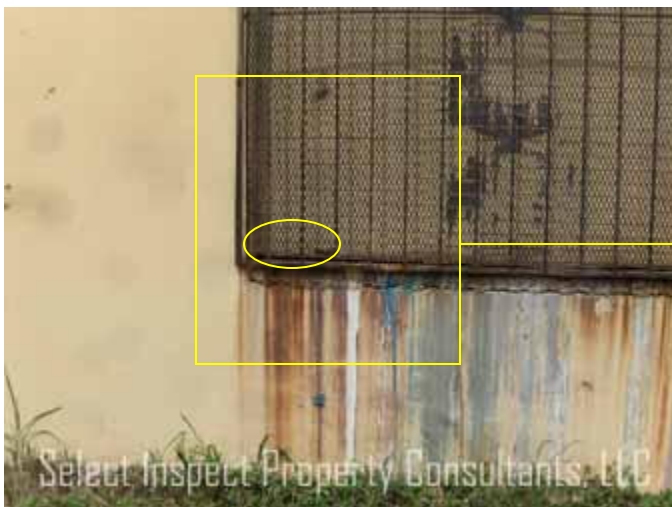
↑ Thermal imaging implies energy loss at the east-northeast overhead door; weatherstrip was in poor condition; corrosion & moisture in the concrete are prone to promoting further deterioration of the concrete & steel components; routine maintenance is recommended

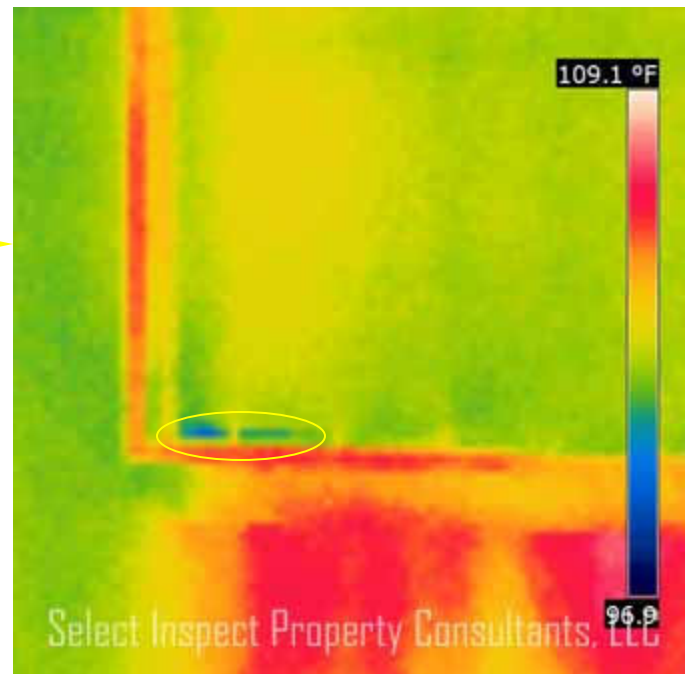
↑ cool air escaping at damaged weatherstrip; may also likely be allowing infiltration to conditioned space seasonally; apparent rodent gnawing evidence was seen as well.
