FPE Panels – Hazard or Hype?

This article focuses on the controversy over inspecting and reporting Federal Pacific panels. It has been published in the magazine for the California Real Estate Inspection Association and in other technical journals.

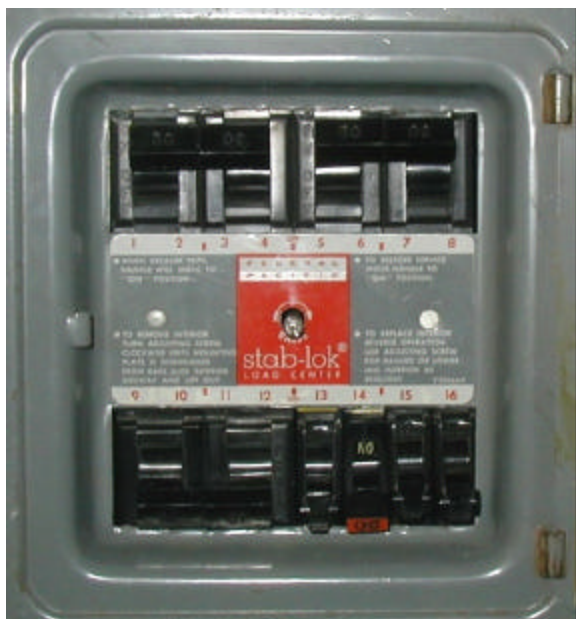
Since the 1984 edition of the NEC, breakers that operate with their handles in a vertical position must be on when in the up position, and off in the down position. Prior to that time, several manufacturers made equipment such as that seen in figure 2, with a row of breakers that was on when down and off when up. The word “on” when upside down is “no.” Inspectors encountering such equipment might want to warn their clients that these FPE breakers are on when facing the outer edge of the panel, and off when facing the center of the panel. It can be very difficult to remove these covers without accidentally tripping a breaker.

Figure 2 – Breakers that are on when down

Inspectors might find that their first problem with FPE is the difficulty in removing the deadfront cover without tripping the breakers. Several models of FPE panels have breakers that are on when the handle is positioned toward the outside of the panels. The handles stick out slightly over the deadfront, past the twist-out opening for the breaker. To remove the cover, it is necessary to first lift it slightly away from the panel, then slide it under the handles of one row while lifting the cover off the other row. If an inspector pulls the cover straight off, it is likely that some of the breakers will accidentally trip. The panels in figures 2, 3, and 4 have this problem.

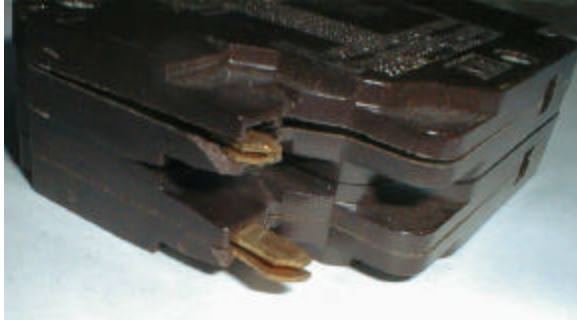
Figure 8 – Damaged “E” type breaker

Not only do “E” breakers make poor connection to “F” sockets, forcing them into the socket can damage them. The breaker may split when shoved into the slot, with the bus stab receding inside the breaker (figure 7). Since it is now making a very loose contact to the bus, the breaker might fall right out when the deadfront cover is removed (figure 9). Inspectors can be forewarned of this condition before taking off the cover. Simply look at the label for the panel to see where the “E” slots are located and whether any “E” breakers have been inserted into “F” slots. When finding that situation, there is no need to remove the cover to know that the breaker is in the wrong position.
